Moving food and drink

Manual handling solutions for the food and drink industries

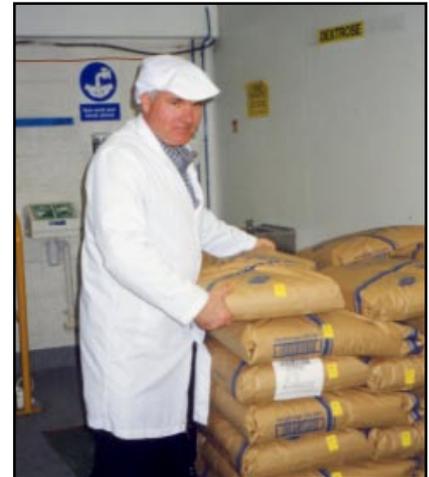
In 1992-3 suppliers delivered raw materials (eg sugar, crystal gum, gum arabic, pectin and liquorice) to the company's warehouse on pallets in 50 kg sacks. The pallets had to be unloaded manually, and the sacks carried to the hoppers at the start of the lines. The sacks did not have good handholds, and the contents were likely to shift unpredictably. The workforce in the delivery area needed to carry up to two dozen sacks per shift and pour the contents into the hoppers on the four lines.

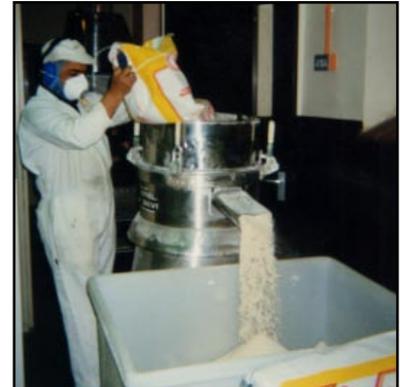
In 1991, raw materials such as flour, cocoa powder, sugar and oats were delivered to the site in 50 kg sacks, stacked on pallets. All these materials had to be sieved before they could be used. Staff had to lift the sack onto their shoulder and pour the contents into the hopper of a sieving unit. The top of the hopper was approximately 1.5 m above ground level.

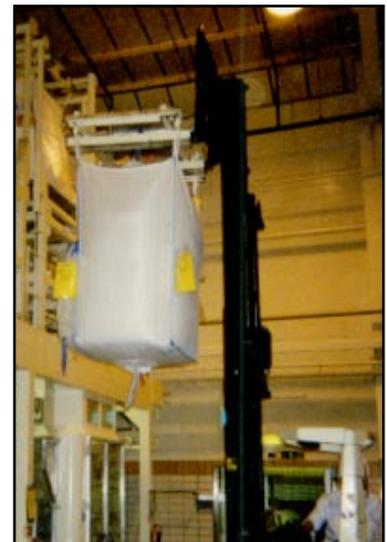
Following risk assessments, the company decided to get rid of the manual handling completely. They put into practice a 'big bag' method. The raw materials are now delivered in quantities of 1 tonne. These are lifted up and positioned over the hoppers using fork-lift trucks, and the materials are dispensed directly into the hopper funnels. The main cost was in modifying the discharge points above the machine. This was approximately £12 000 per point.

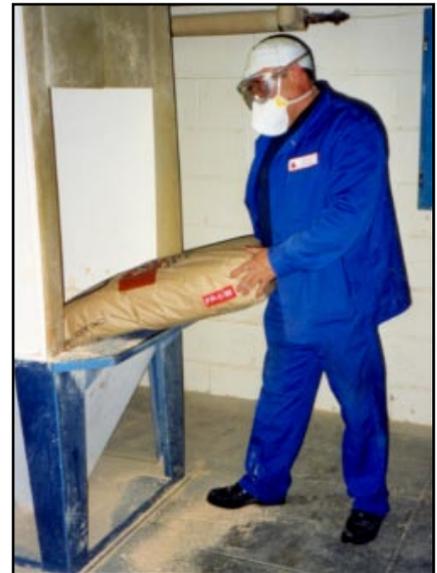
Following a risk assessment, the company installed a big bag hopper. The filter powder arrived in 350 kg bags on a pallet, a pallet truck lifted the bags onto a hoist and the contents were automatically emptied into the hopper. The system cost the company approximately £20 000.

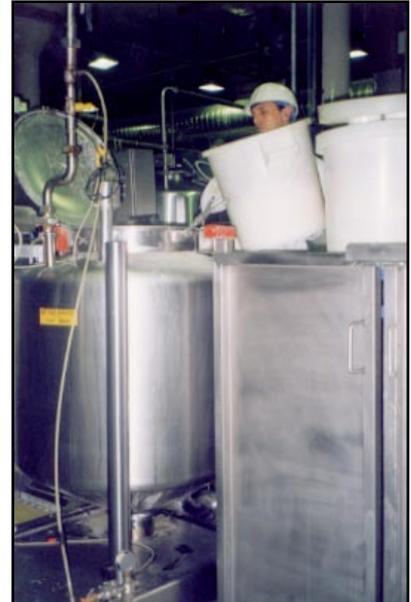
The company installed a platform next to the hopper on which drums could be rested while the contents were tipped into the hopper. The approximate cost of installing the platform was £250.

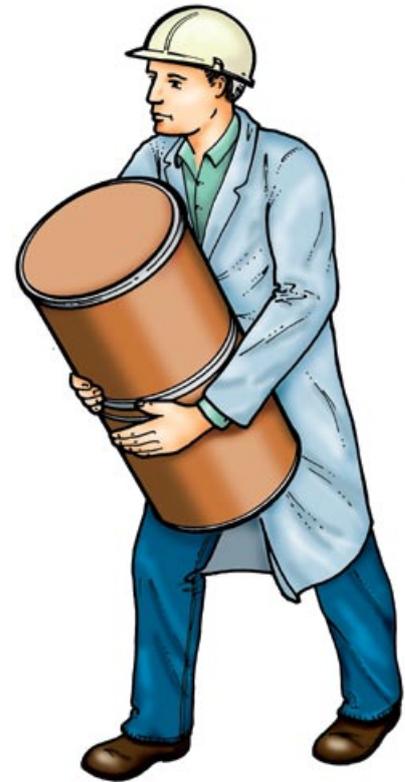
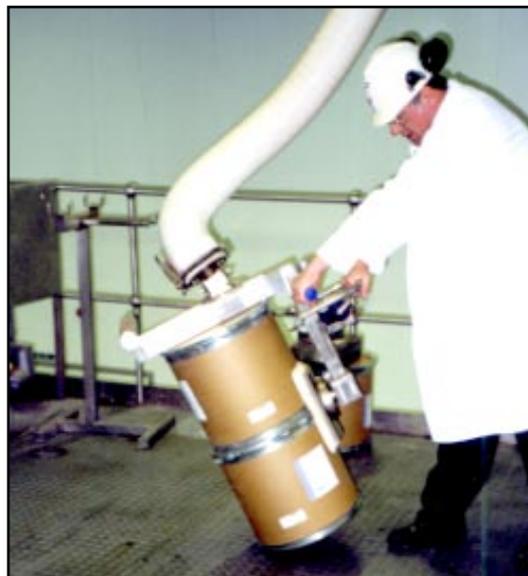
The company bought an attachment to an existing vacuum lift which was designed to pick up kegs by suction. This attachment cost approximately £750.

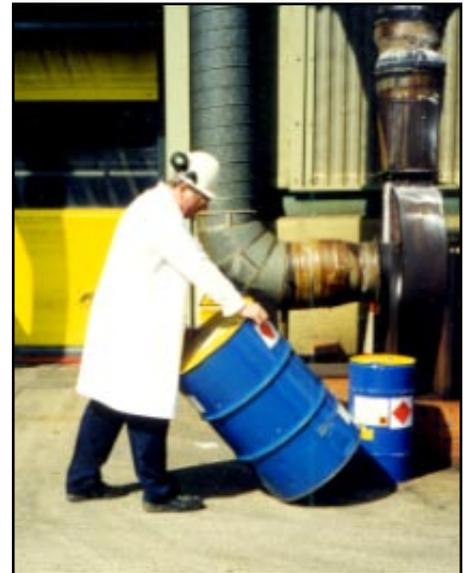
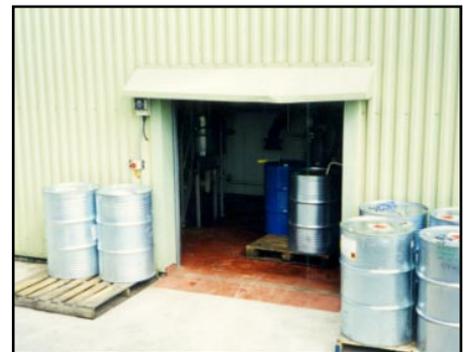
- The drums contained liquids of varying densities and were prone to unpredictable movements.
- The drums were difficult to grasp and could easily slip out of the operator's hands.
- As the drums were rolled across concrete, metal splinters occurred.
- The operators had to reach and stoop to counterbalance the weight.
- Rolling the drums required technique and experience.
- The workforce complained about this task being 'awkward'.
- During winter months, the operators occasionally slipped on snow and ice.

The company arranged for the drums to be delivered into the plant (through steel shutter bays) by fork-lift trucks, directly to the liquid charging lines.

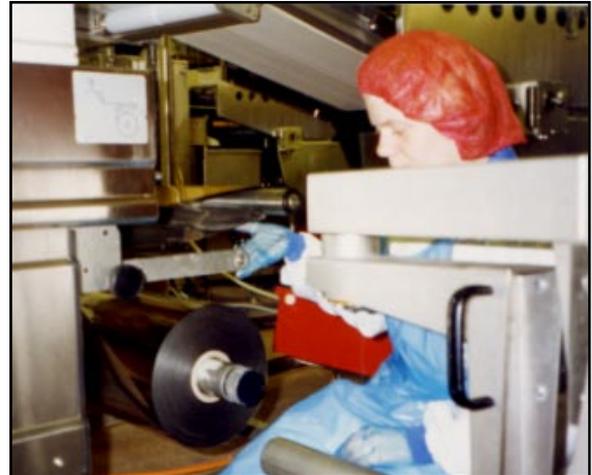
Sliced cooked meat was packed into 'thermoformed' plastic pouches, which consisted of a moulded plastic base and a plastic film lid. The plastic sheeting which goes through the thermoformer was delivered in rolls which fitted on an upper and lower spindle of the machine. The upper roll fed the film which made up the lids, the lower fed the film which made up the moulded plastic base.

The rolls of plastic film weighed between 60 and 75 kg. The rolls were between 420 and 560 mm wide, with a diameter of approximately 450 mm. The machine had to be loaded a couple of times per day. The rolls were difficult to grasp, had no good handholds and presented a risk of finger-crushing as they were loaded onto the spindles. The spindle heights were below knee level and above shoulder level. It was a two-person lift to get the rolls into place on the spindles, and changing the rolls required the lines to be stopped, so speedy replacement was also important.

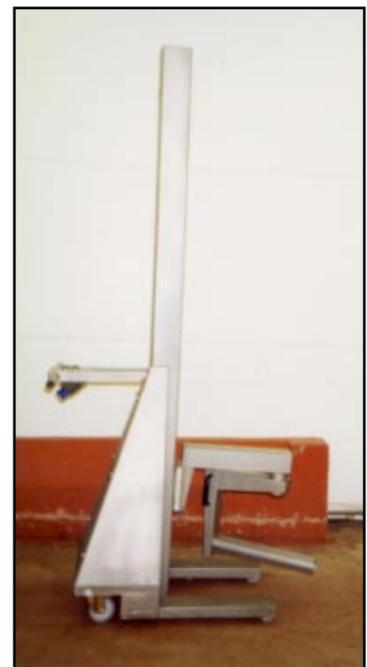
The occupational health sister had brought the problem up at a safety co-ordinators meeting (held for all safety personnel across the company's sites). An electrically operated 'easy-lift' reel lifter had been in use at one of the company's other sites. The easy-lifter could pick the reels from the loaded trolleys, and then was pushed to the line, where the reel was slid across onto the spindle. She asked the manufacturer to give a demonstration to a team consisting of the production manager, the safety engineer, and a couple of employees from the line. This resulted in a week's free trial of the product, to try out in the cramped conditions of the packing lines.

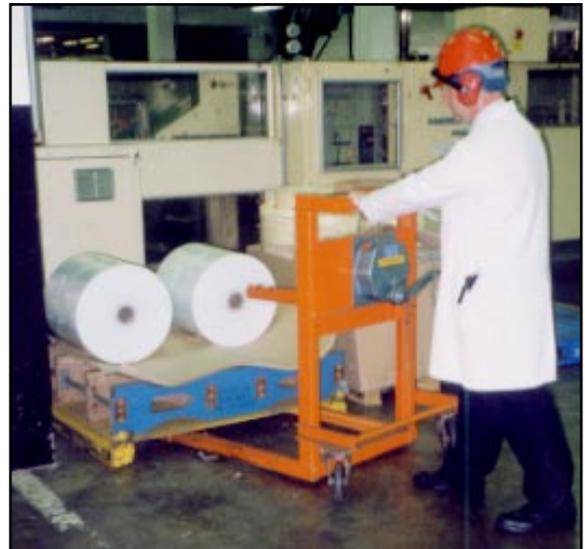
Rolls of shrink-wrap film, weighing 75 kg, were delivered to a packing department on pallets stacked two high. The rolls were presented standing upright (vertical) and had to be manoeuvred onto their side to load onto a carrier for transport to a wrapping machine.

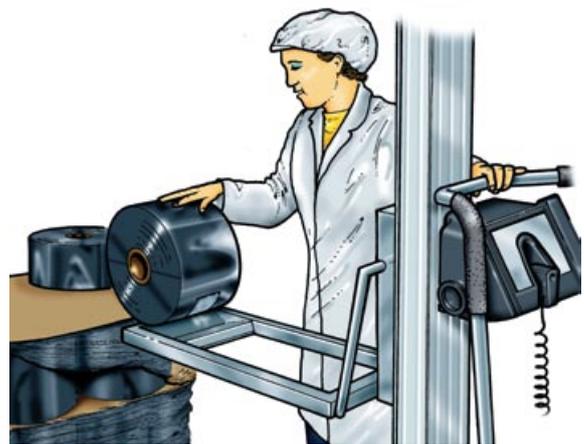
The problem was discussed at the company's monthly health and safety meeting. The company had tried out a reel-handler three years previously, which had not worked well. However, they decided to look on the market again, to see if an improved product was available. They located a mobile, battery-operated reel lifter which lifted the reel to the correct height, where it could be slid easily into place by the operator.

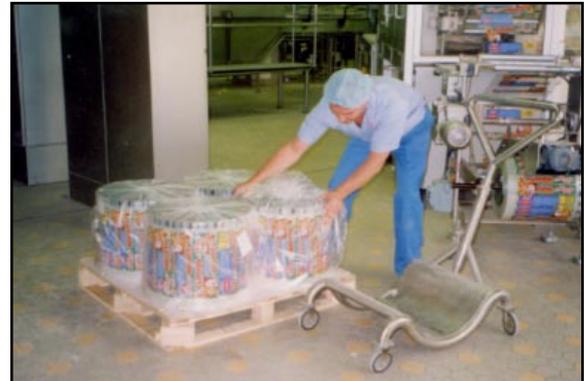
Reels of inner liner, weighing 25 kg each, were delivered to a cereal manufacturer on pallets, stacked three high. The reels were turned onto their side manually and either rolled to a packing machine, or lifted onto a carrier using a mandrel and hoist. This task was carried out every two hours.

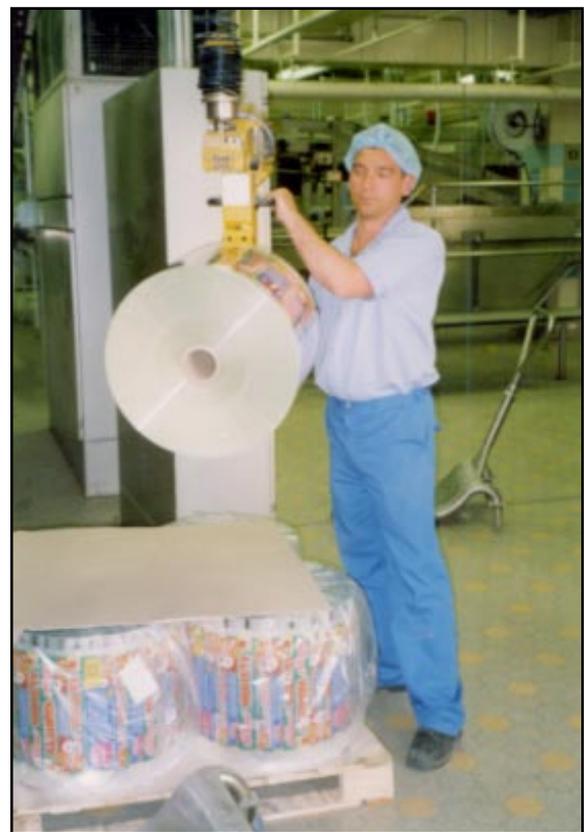
A risk assessment was carried out as part of the company's policy to reduce manual handling. The company installed two lifting aids at a cost of £20 000 each. These lifting aids have expanding chucks which are inserted into the core of the reels, and by means of compression, the chucks tighten against the core and the operator is able to lift the reel.

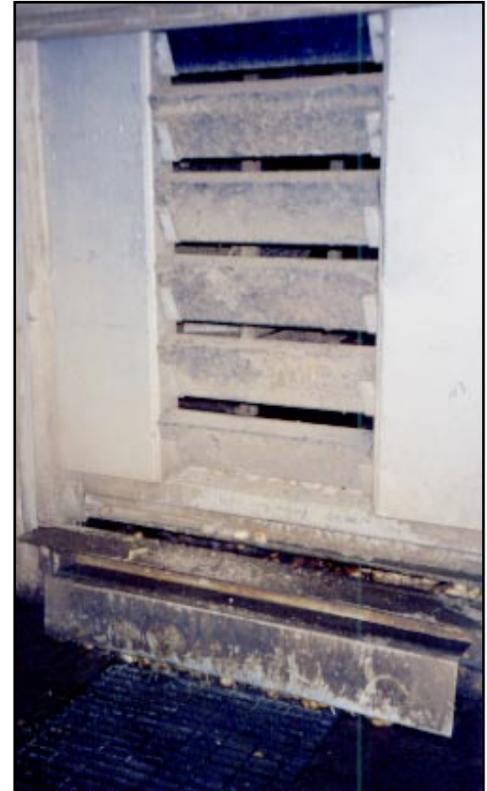
In a potato factory, potatoes were bought in and stored in potato storage bins, the size of a small room. When they were ready to be used, three of the heavy wooden boards that covered the entrance of the bin were removed and a hose was inserted. A worker would enter the bin and use the hose to force the potatoes into a flume to travel to the washing stage. If they could not be moved with the water, workers would use a tool, similar to a rake, and move the potatoes manually. Two people were involved in the task during each shift.

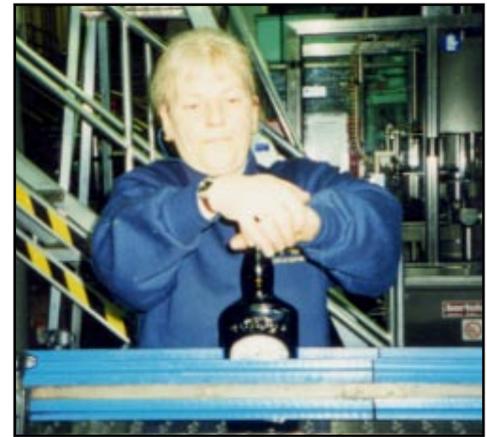
'Mushroom'-shaped cork stoppers were used to seal high-value bottles of malt whisky. Cork was a difficult material to use mechanically, so the stoppers were inserted by hand. Staff put a leather patch onto their palms, locked their hands together and, raising their shoulders, used considerable force to push the stopper into the whisky bottle. Six people were involved in this operation, inserting anywhere from 3 to 14 stoppers per minute.

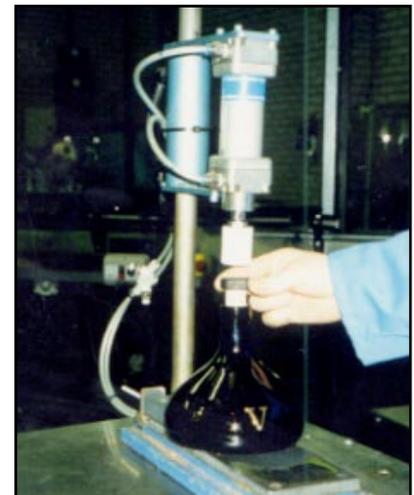
In consultation with the staff on the line, the company engineers built machines that could insert the stoppers mechanically. The operators pushed the full bottles into the machine, inserted the stoppers into the machine, closed the machine guard, and a piston then pushed the stoppers slowly into the bottle. Some machines were designed for single bottles, where the operator held the cork in place, and using a foot pedal, a piston pushed the cork slowly into the bottle. The machines were all made in-house, at a cost of less than £500 each.

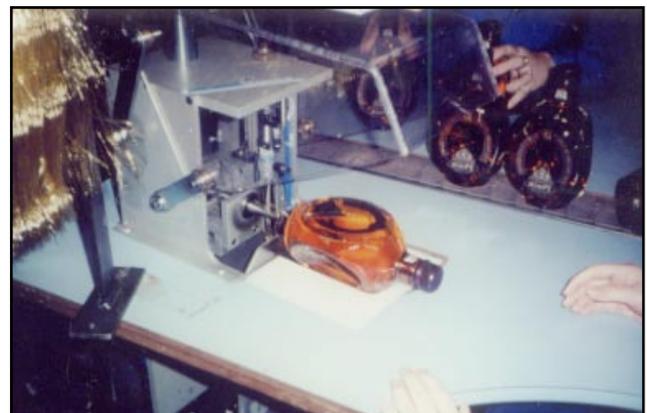
The operator held the clippers laterally with the blades pointed to one side because of the orientation of the bottles and the height of the conveyor. This caused the operators to bend their wrists downward as they repeatedly applied pressure on the clippers. The combination of such repetitive motions, poor wrist posture and high gripping forces presented a risk of upper limb injuries such as carpal tunnel syndrome or tenosynovitis. Some operators were reporting early symptoms of these disorders.

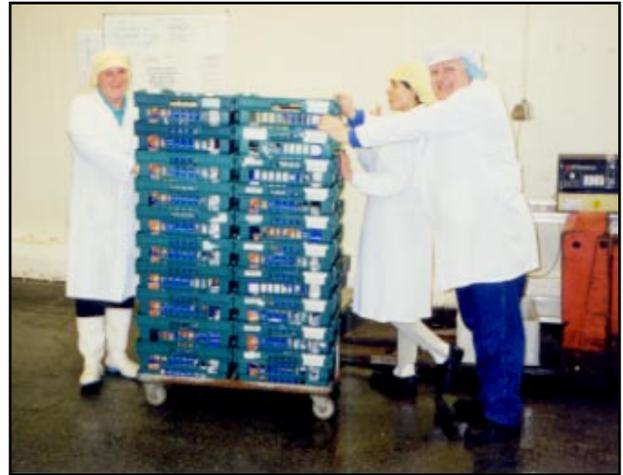
Strains and sprains associated with pushing and pulling racks of product were common. The cause of these problems was often associated with damaged rack wheels. It was often difficult to determine whether a set of wheels was faulty until the rack was fully loaded, and the temptation was then to push it anyway, rather than unload and reload another rack.

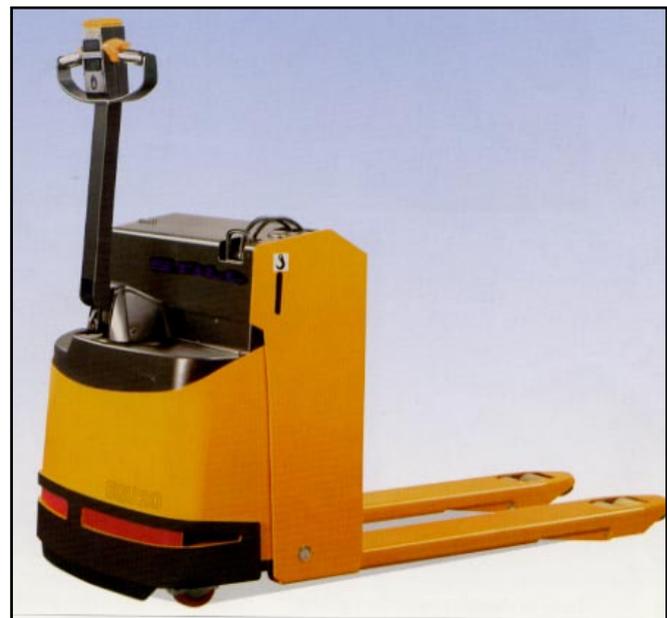
The company wished to identify a cost-effective solution. They asked their supplier of fork-lift trucks if they knew of a suitable product which would make the task easier. Their supplier had a solution in the form of battery-operated power trucks. They rented 11 trucks at a cost of £57 per week each, and sent their staff on a half-day training course in the safe use of these trucks. Fifty people were trained to use them, and about a dozen people would be moving product

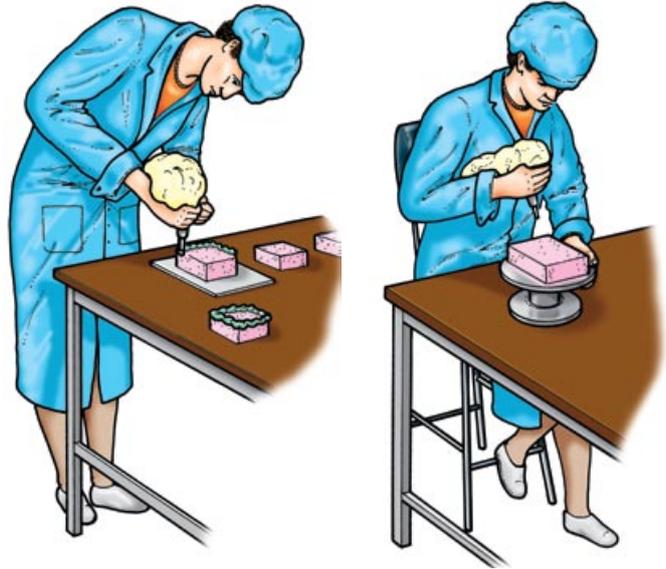
- To use the icing bag effectively, operators had to adopt stooped and static postures.
- Repetitive movements were required.
- The operators had to adopt static and fully flexed arm postures while supporting and squeezing the icing bag.

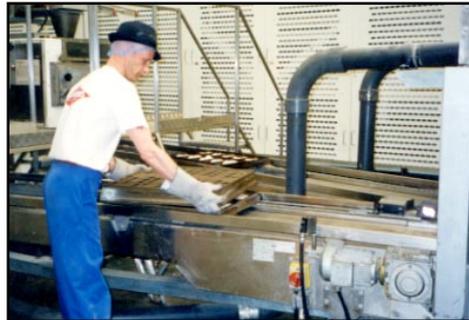
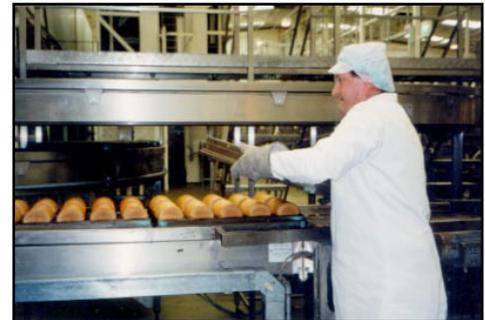
One or two operators placed lids on baking tins and removed lids from baking tins at a rate of 650 tins per hour. Each lid measured approximately 0.7 x 0.6 m and weighed 6 kg.

Staff had been complaining about the repetitiveness of the task and also the weight of the lids. Putting lids on and taking lids off the tins caused the operators to stoop, twist and hold loads away from the trunk. Operators also had to reach up to the stacks of lids and were suffering burns when taking hot lids off the tins. If lids were placed on the tins incorrectly, the oven would jam.

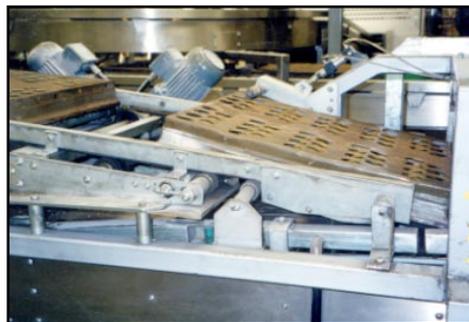
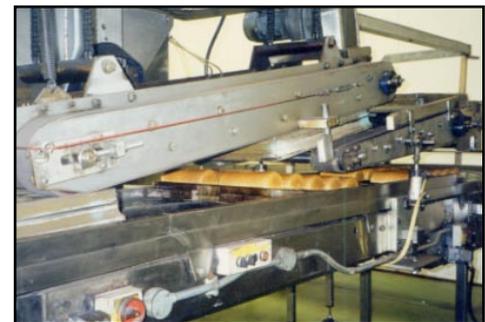
The company installed a machine which put on the lids and a second machine which took off the lids. Each machine cost approximately £16 000.

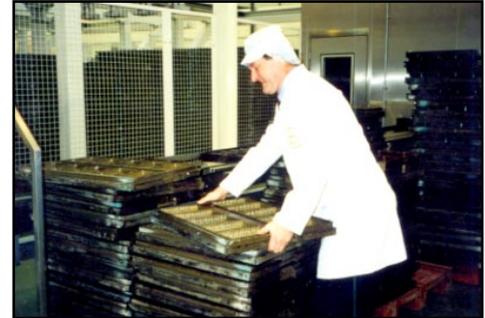
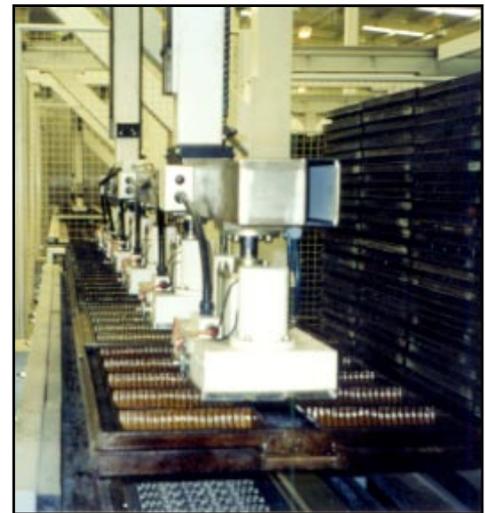
The company installed automatic tin stores which remove tins from the line and place tins on the line. The automatic tin stores cost approximately £350 000.

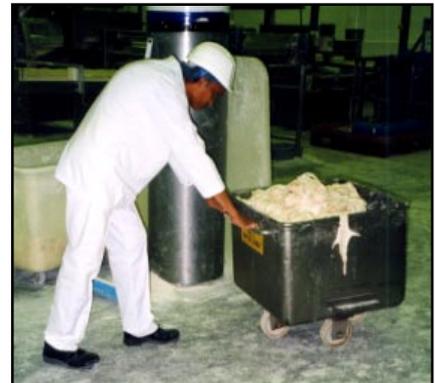
The company replaced the plastic bins with wheeled metal carts that became available when a conveyor was installed in another part of the factory. (A new cart would cost approximately £80.) The carts, weighing approximately 45 kg, are pushed by the operators to the scales and the required pastry is manhandled into the mixing bowls.

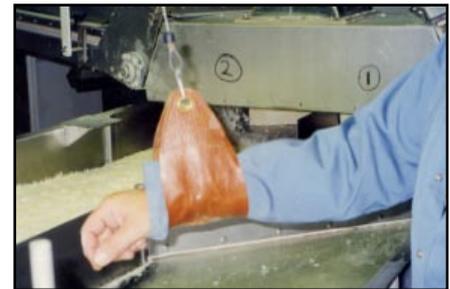
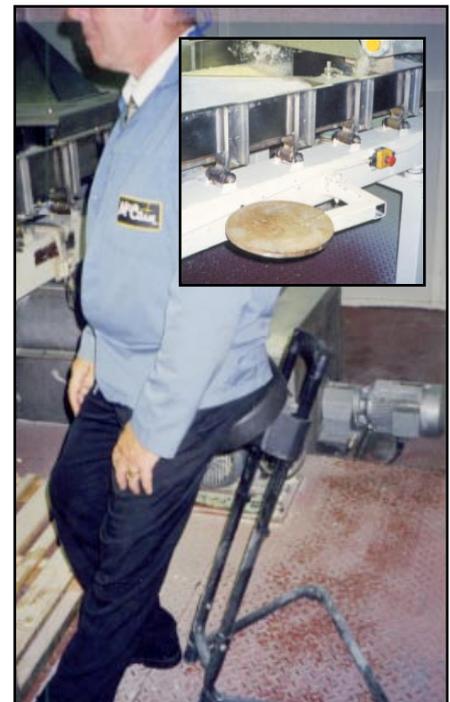
The manual handling instructor noticed that the inspection task was similar to one in the packing area of the factory, where staff had complained of arm fatigue. The inspectors had been trained not to touch or rest their arms on the inspection table while working. However, the manual handling instructor realised that the inspectors needed a way of supporting their arms to prevent static loading of the muscles and to offer relief. He also noticed that the seating provided for the task, a wooden stool fixed to the vibrating table, was inappropriate as it would channel the vibrations to the inspectors.

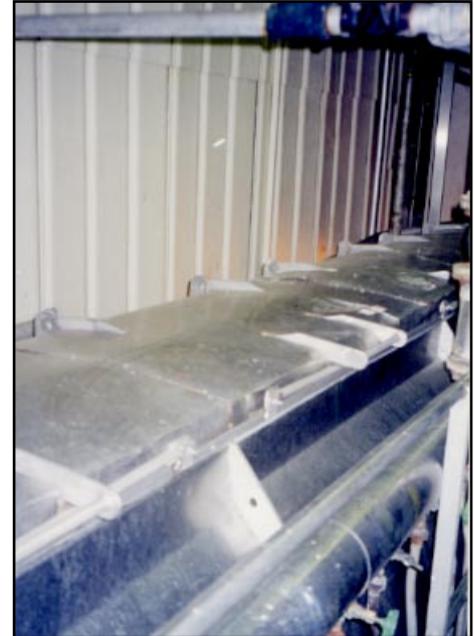
The blanching lids were large and insulated, which made them very heavy. As a result the task involved strenuous pulling to lift the lids, followed by strenuous pushing over a large distance to open them fully. The workers complained that the lids were too heavy and that they were finding the task difficult.

An in-house risk assessment was performed and the manual handling risk to workers was identified. The problem was solved in two ways. The first part of the solution was to add a counterbalance to the lids to reduce the effort needed to lift them. With this system in place, the workers could lift the lids with little effort, ie move them up and down with their fingertips.

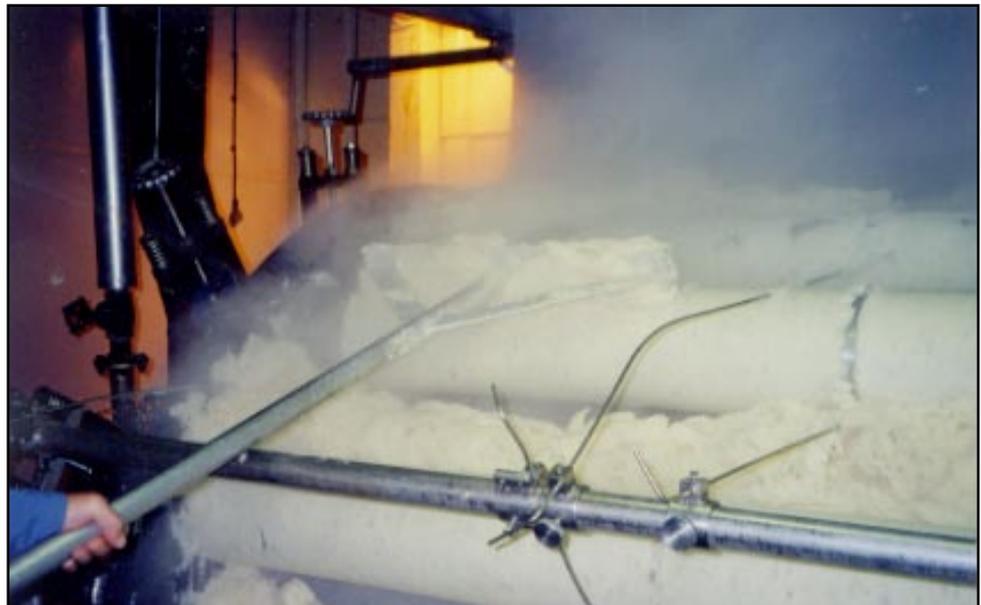
The scraping task presented a risk of injury to upper limbs as it involved strenuous reaching and stretching while holding a heavy scraper, weighing approximately 10–12 kg. Workers identified the problem and one of them put forward a solution as part of the 'bright idea scheme' run by the factory.

The solution was to attach a stainless-steel bar with a number of thin metal rods or 'fingers' parallel to the rollers. The metal fingers were of different lengths to enable them to rest on the top and second roller. These fingers dragged the product off the roller and onto the one below it. The cost of the solution was £300.

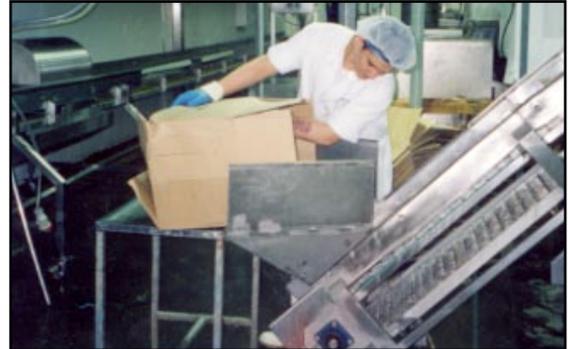
Frozen fish fillets were stored in bulk plastic bins (1.2 m long, 1.0 m wide, 0.75 m high) which hold 227 kg of fish, or cardboard boxes (60 x 38.5 x 30 cm) which hold 23 kg of fish. These bins/boxes were transported to the various process lines. The fish were then lifted out of the bins or tipped out of the boxes, and deposited onto the process line.

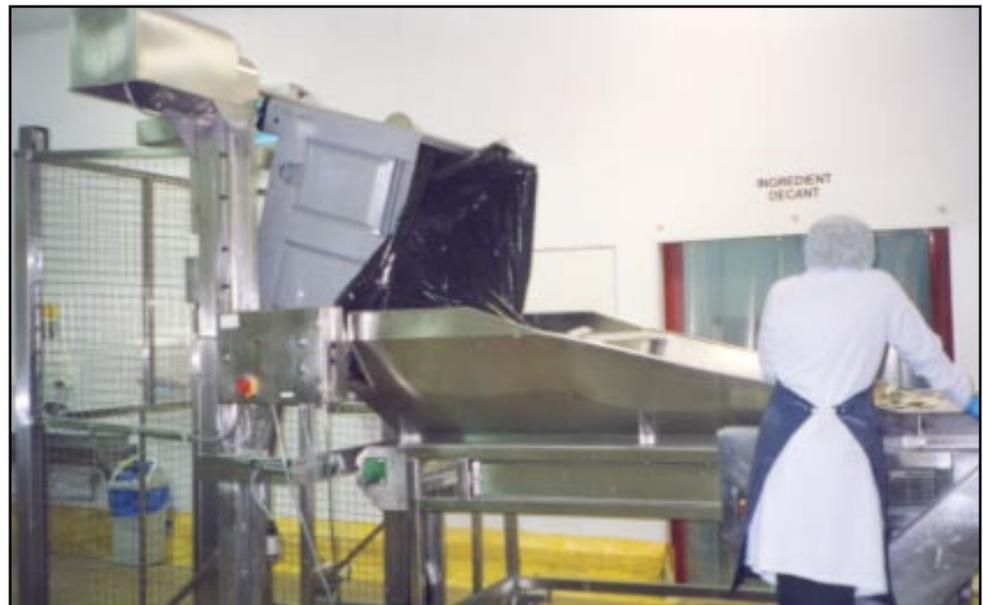
The company phased out the use of cardboard boxes. To remove the reaching associated with the bins, they worked with a local engineering firm to design and build a hoist which lifted the bin to process line height and tilted the bin to deposit the fish onto the line. The company purchased 15 of these hoists at a cost of approximately £2500 each.

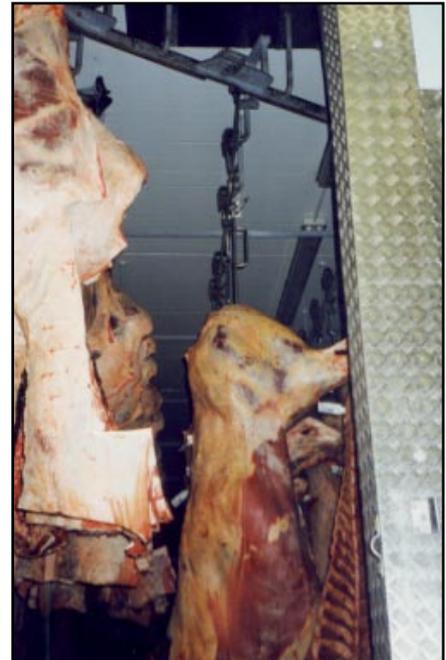
Beef quartering involved cutting a beef carcass in half using a hand-held air saw. The carcass was suspended from a ceiling rail using a hook through the H-bone. It was cut horizontally through the middle, to separate the fore and hind portion. When the carcass was severed half way, the operator attached a rope to the forequarter, then, using his body as a counterweight, the operator swung the rope and lower portion of the carcass up onto another hook on the ceiling rail. Once on the hook, the cutting of the carcass was resumed until the fore and hind portions were severed and on different hooks. Eight men (humpers) worked in the quartering hall and quartered up to 200 carcasses during their eight-hour shift.

An air-operated quartering hoist was installed which lowered a small portion of the ceiling rail containing a hook. The beef was cut half way and then the operator attached the piece of rope to the forequarter as before. Instead of hauling the carcass onto the second hook manually, the operator used the hoist to lower a section of the overhead rail. The loose end of the rope was fitted over the hook. Using the hoist, the rail, hook and carcass were raised up to a comfortable height for cutting through the rest of the carcass until the two portions were separated.

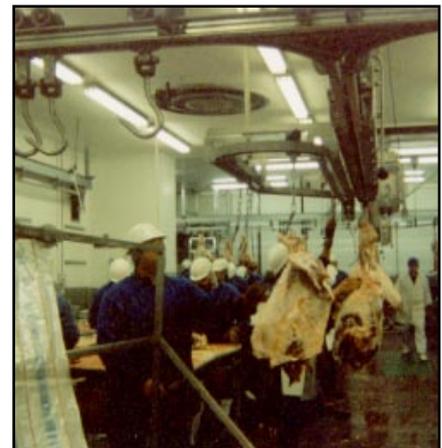
This set of tasks presented a manual handling risk because it required the lifting of large pieces of uncut carcass in awkward postures. The boners/trimmers had to stretch with the hook to reach the meat, followed by strenuous pulling of the meat to transfer it from the conveyor belt to their trimming table. They also had to support part of the weight of the meat in one hand during boning and to lift the joints back onto the conveyor at the end of the process.

The company designed and installed an 'eez-away' line to reduce the amount of manual handling. The quartered beef is transported on a rail system, the speed of which can be controlled by the operator. A hook is attached to the main bone in the carcass and, as the operator cuts, it gradually pulls away the bone. As the operator cuts out each joint, they are placed on the table in front of the trimmers, who are situated at right angles to a removal conveyor. At the end of the line, the bone drops directly into the waste container.

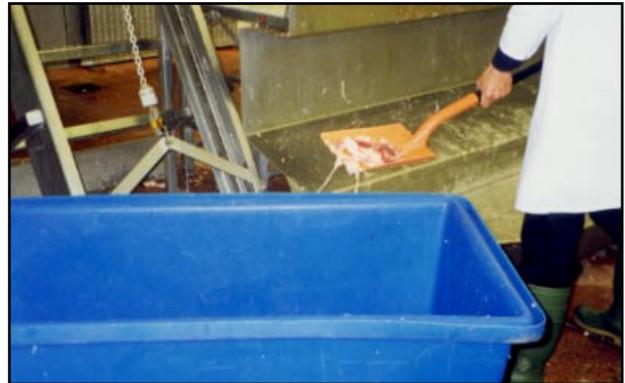
During preparation of joints of beef and lamb, fat and gristle was removed from the cuts of meat before being sent to the chilling stage. The waste fat and gristle was shovelled from the trimming line into a waste container.

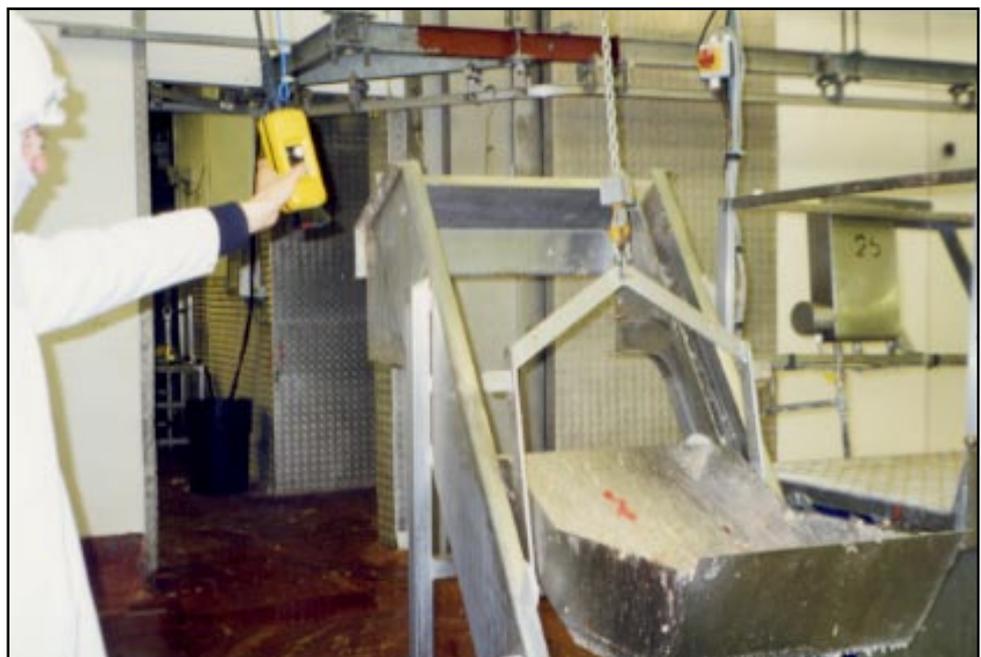
The company installed a conveyor, a waste hopper and hoist to reduce the amount of manual handling. The conveyor transports the waste fat and gristle along the trimming line and drops it directly into the hopper. When the hopper is full, it is lifted hydraulically and tipped into the waste container.

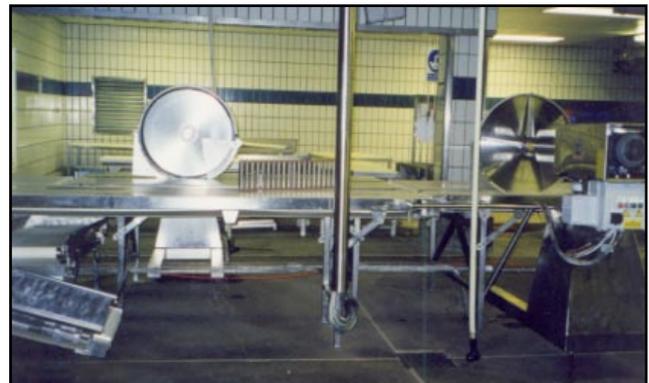
The task required manual lifting, strenuous pushing and pulling to move the pig carcasses along the rail, and considerable force to cut the meat into smaller joints. The quartered cuts of meat were heavy, cold, and difficult to grasp. The operation was also noisy, at over 90 dB(A).

The butchery department was fitted with a semi-automated system of equipment and new working procedures. Half-carcasses were transferred automatically from the chiller room onto a conveyor belt. An operator manoeuvred the

carcass into the correct position for a circular saw to remove the hooves, back legs and loins. A second, closed saw made further cuts. The resultant joint of meat was lifted onto a conveyor, and a team of eight butchers on the line would each then make a smaller cut from each joint. A system of task rotation was implemented so that the butchers took turns to carry out different cutting and conveyor-loading tasks. Each workstation had a knife-sharpening device to help keep the knives in top cutting condition. Instead of stainless-steel, the conveyors were made of hygiene-standard plastic, designed to stop the meat sliding about, to make the cutting operation easier.

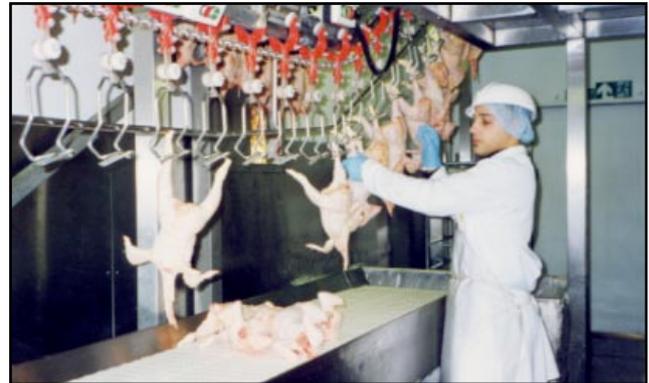
Birds attached to a shackle by their legs were knocked off onto a conveyor. Six operators would lift the birds, which weighed approximately 1.5 kg, and hook them onto another shackle line ready for the next process.

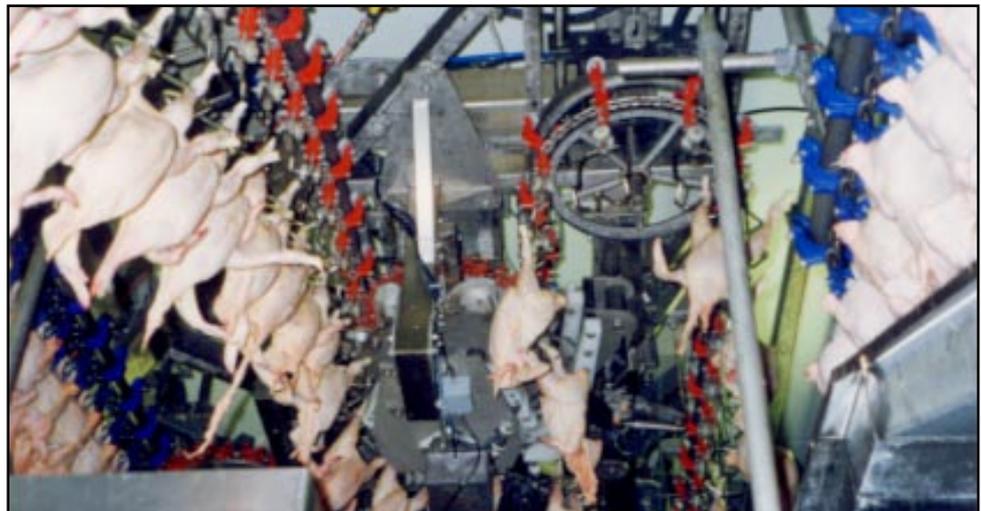
The company installed automatic changeovers which transfer the birds from one line to another.

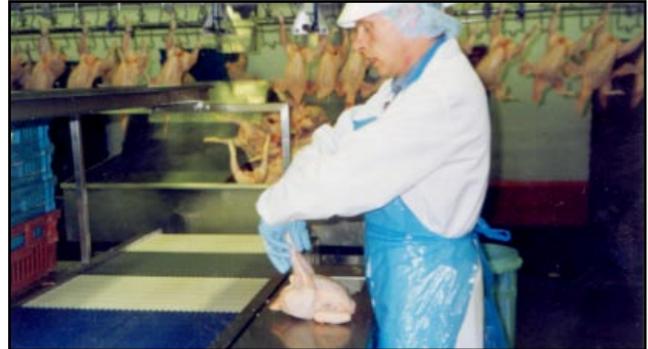
Following evisceration, birds were chilled to between 0 and 2 °C and passed to the trussing department. Twenty staff were trussing the birds by hand - tucking the wings under, forcing the leg shank into the cavity and wrapping round with a trussing band.

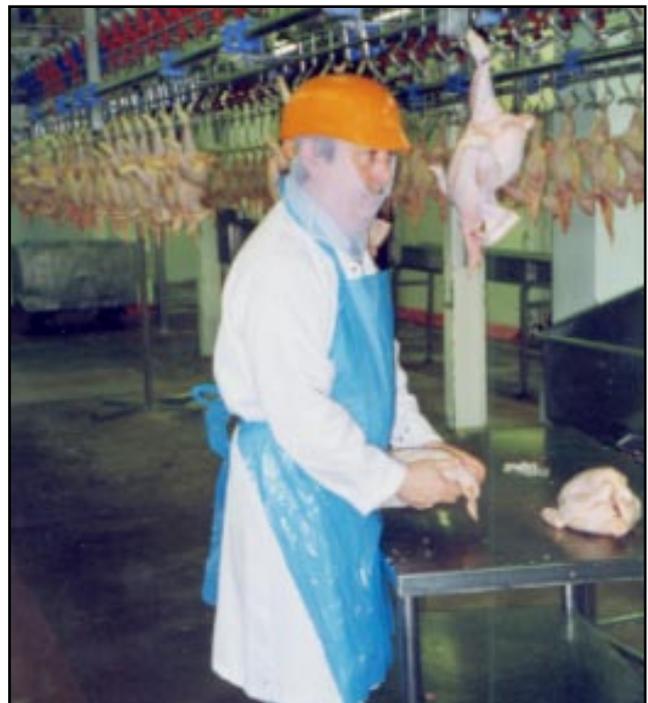
When setting up a new site, the company changed the working procedures so that the birds were chilled after, rather than before, trussing ('hot' trussing).

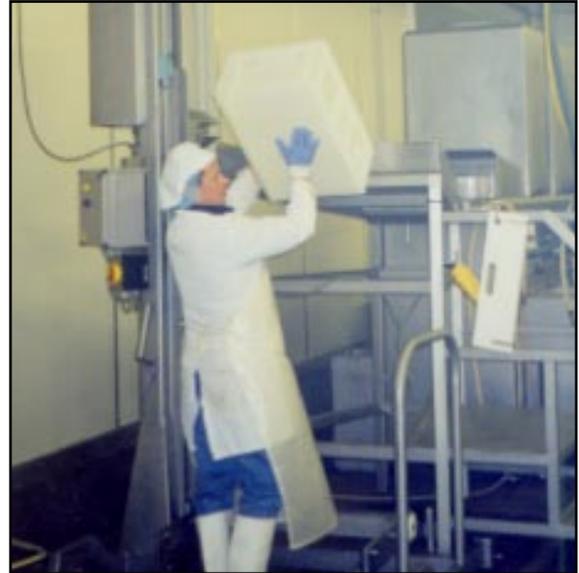
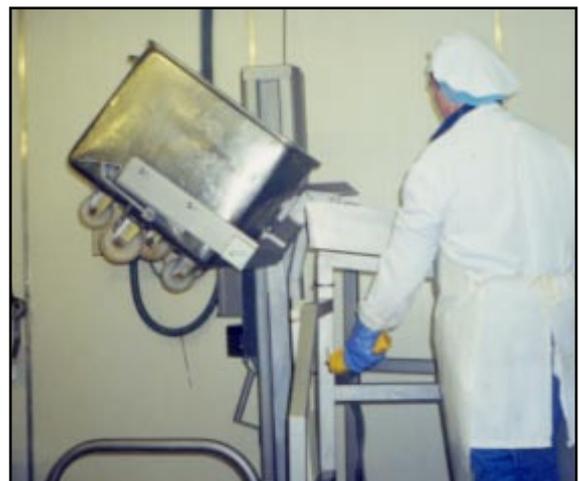
The production manager identified a hoist that could be fitted to the infeed which would lift and tip a stainless-steel tub of bacon cuts into the machine. The cost of the hoist was approximately £1500.

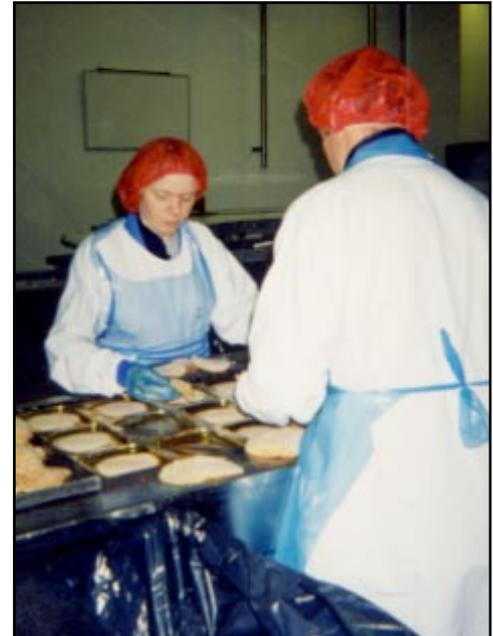
Sliced cooked meat was packed into 'thermoformed' plastic pouches, which consisted of a moulded plastic base and a thin lid. The meat was sliced mechanically, and emerged from the machine in a 'shingled' form, ie with, say, six slices of meat overlapping slightly for attractive display in the pouches. Forty employees moved the cooked meat off the slicer conveyor into the plastic pouches at a rate of approximately 80 packs per minute. Each pack weighed between 100 and 200 g.

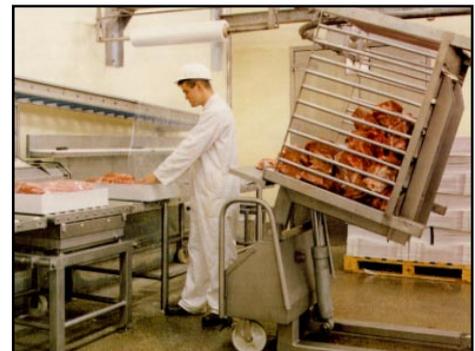
The safety manager wanted to eliminate the leaning, stooping and reaching associated with the packing task. He identified a company that supplied hydraulically operated wheeled devices which could lift bins weighing up to a tonne. The device tilted the bin, and presented the meat cuts to the operator at a comfortable height. The company purchased six of these machines at a cost of £5500 each.

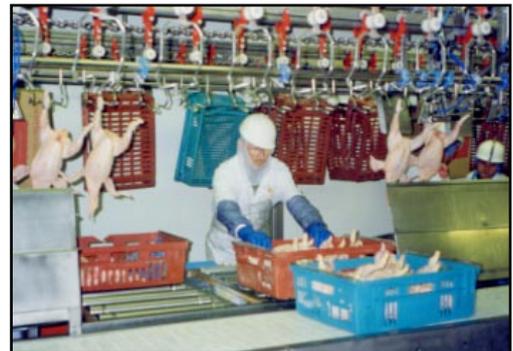
The company relocated this process to a purpose-built room. The empty crates/boxes are picked from a moving line behind the operator and placed on a roller workbench. The crate is filled and then pushed forward onto a conveyor via these rollers. The full crate was then transported automatically to the despatch area.

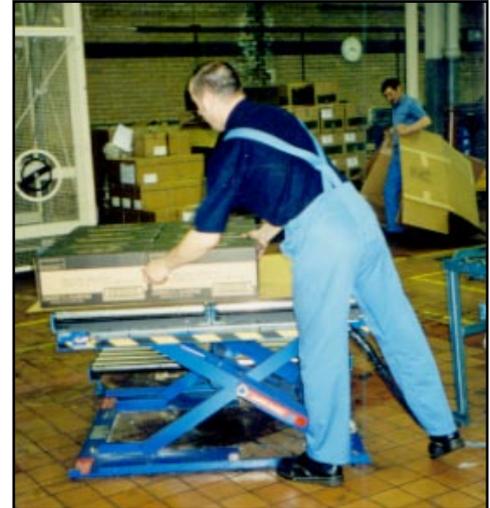
Full cases of whisky, usually containing 12 bottles, were transferred from the end of the conveyor onto wooden pallets. Depending on the contents, the boxes weighed between 15 and 25 kg. Staff lifted each box by hand from the line to the pallet. The line produced 55 bottles per minute, resulting in a pallet-building rate of four to five cases per minute. The shift length in the plant was at least eight hours, with a 15-minute break in the morning, half an hour for lunch, and another 45 minutes taken as and when required. Thirteen people would be occupied on this task across the eight lines in the bottling plant.

The task involved considerable heavy, repetitive lifting. Staff would bend down to stack the lowest levels on the pallet, and would have to reach forward to place boxes at the back of the pallet. There had been reports of backache from staff, and the company had received some compensation claims associated with the palletising task.

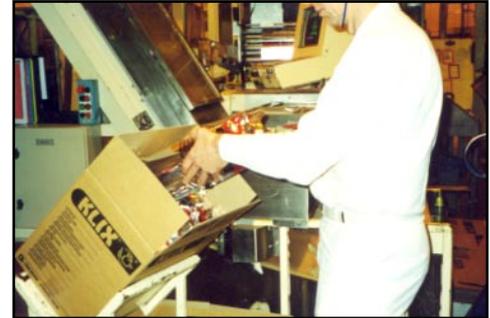
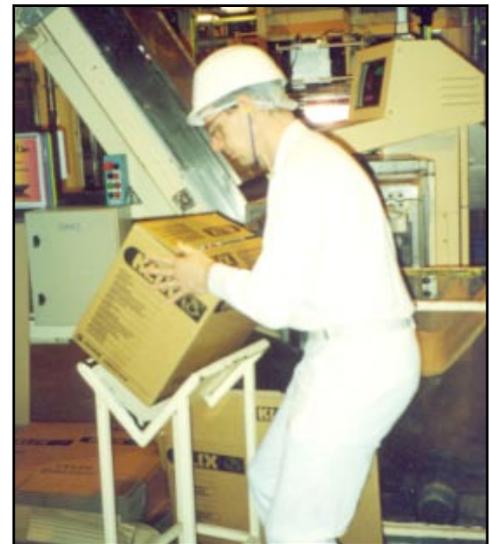
At the end of a production line for vending-machine cups, the filled cups had to be packed into boxes. A 'stick' of 25 filled cups was wrapped mechanically, then delivered in a horizontal orientation to a packing station at a rate of 20 wrapped sticks per minute. A packing operator would grab three sticks at a time, turn them through 90° into a vertical orientation, and place them into a box. Each 'stick' weighed about 500 g. When a box was full (approximately 20 sticks), the operator would seal it, pick it up, twist through 90° and place the filled box on a conveyor belt to go to the palletising area. Six operators would carry out this activity throughout a 12-hour shift.

The company decided to automate the task completely. They purchased two custom-built prototype machines, tested them out, then purchased four more. These machines pack the sticks straight into the boxes. Finally, they replaced the two prototype machines. Each machine was installed at a cost of £120 000.

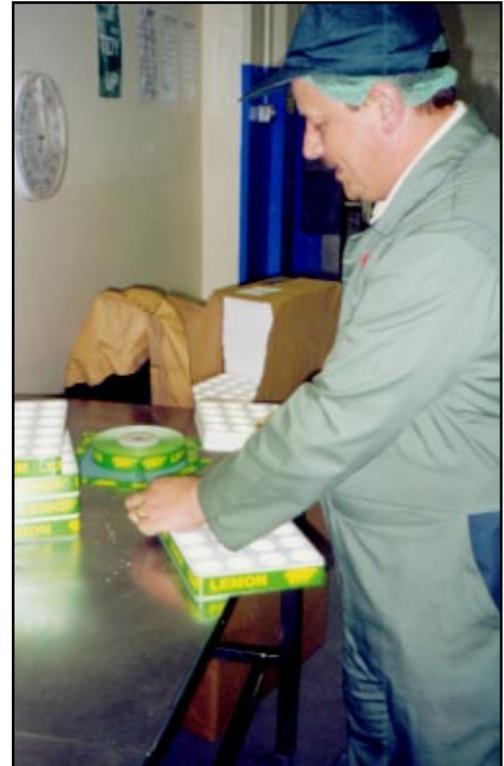
- The operator was forced to twist while turning the tray.
- The task was highly repetitive.
- As the tape was cut with a knife, minor cuts could occur.
- Staff described the task as 'boring' and the one they least enjoyed.
- Operators complained of hand/wrist discomfort.
- Several operators were diagnosed with upper limb disorders.

The company replaced the polystyrene trays with cardboard ones which already have the brand name printed on them.

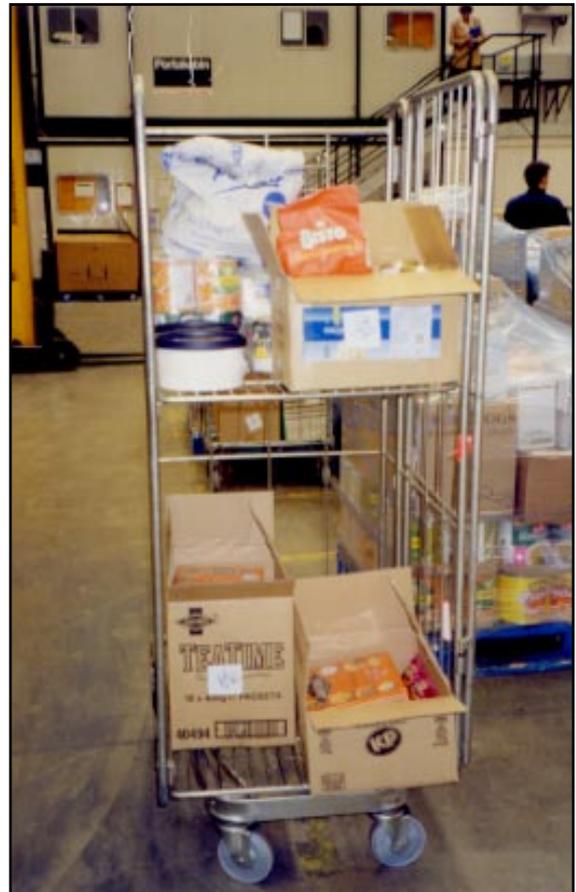
In a food warehouse 'pickers' collected the items ordered by customers. Drivers then delivered them to the customer's premises. A pallet was used to hold the selected items, and this was transported round the warehouse on pallet wagons and/or pump trucks. Pickers loaded the pallets, wrapped them in shrink-wrap and the drivers loaded them on their lorries. At the delivery point the pallets were either unloaded or left to be unloaded and collected later. A total of 120 workers (75 pickers and 45 drivers) were involved in the task.

To reduce the manual handling risk to pickers and drivers, roll cages were purchased. The shelving in the warehouse was reorganised so that heavier items were placed at a comfortable height, and light and/or infrequently used items were placed at a higher level. The roll cages were four-sided metal cages on wheels with a drop-down internal shelf. The pickers selected the items in the warehouse and placed them in the cages, located on picking trucks. The loaders loaded the cages (with a fork-lift truck/vehicle tail lift/loading dock) onto the trucks for delivery and upon arrival drivers pushed the cages to the customer's premises. If a cage had items for more than one customer, it was pushed with all its contents to the unloading point and only the relevant items were unloaded. The remaining items were then returned to the truck in the cage. There was a lock on the door so cages did not open during transportation. Frozen and chilled products were handled separately to preserve the 'cold chain'.

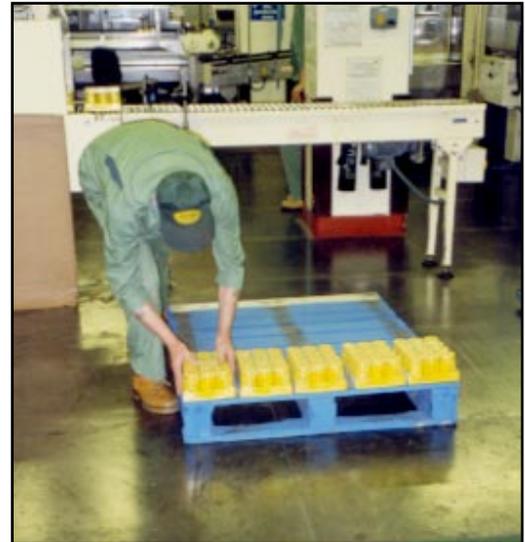
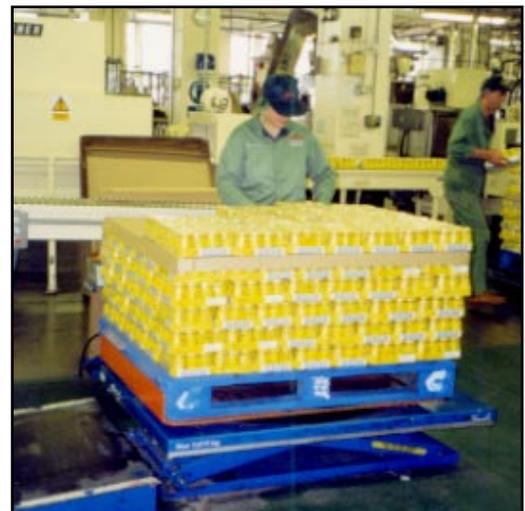
The company carried out a major assessment of the manual handling tasks to see which ones could be simplified or removed. It was decided that this particular task could be simplified by the use of a scissor lift and turntable. The company installed two low-profile scissor lifts on which the pallets were placed. The scissor lifts cost approximately £3000 each.

- The operators no longer had to reach or twist to stack the pallet.
- Operators no longer had to stoop to reach lower levels.
- All complaints associated with the task stopped.
- There was a reduction in lost-time injuries.
