Moving food and drink

Manual handling solutions for the food and drink industries

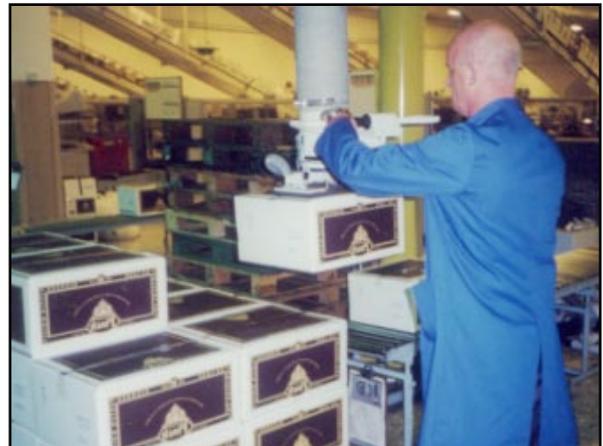
A vacuum hoist was installed for £5000. This device supported virtually the entire weight of the case and the operator only had to exert a relatively small lifting, pushing or pulling force to manoeuvre the load. Also, the operator was in a less stooped posture when placing the cases on the lowest layers of the pallet. More hoists are planned for installation at the other packaging lines in the plant.

- The level of physical effort necessary to transfer 600-900 cases from the conveyor to the pallet was greatly reduced.
- The operators no longer experienced back pain from this task.
- Although the palletising was performed slightly slower when the vacuum hoist was first introduced, eventually the operator could perform the task at the same rate but with much less physical effort.

The palletising of goods is widely performed in the foods industry. By supporting the weight of the load, and allowing the operator to move the load with less effort and in an improved posture, vacuum hoists can greatly reduce the compression on the back and the risk of long-term injury. In addition to handling boxes, the hoist can be used to move items in sacks.

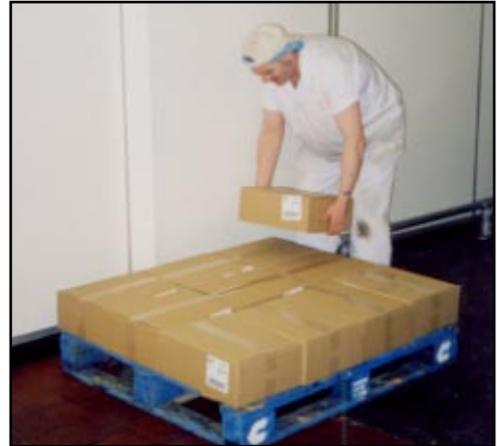
In the wrapping section of a bakery, boxes containing finished product were manually lifted from a conveyor belt and placed on a pallet in a 'brick' stacking order. The boxes were 40 cm long, 28 cm wide and 18 cm high and weighed 5-6 kg. The pallets held 70 boxes. At any one time, up to three different product lines might be coming off the conveyor; each different product had to be stacked onto a different pallet. Each operator handled 1200 boxes (17 pallets) per shift.

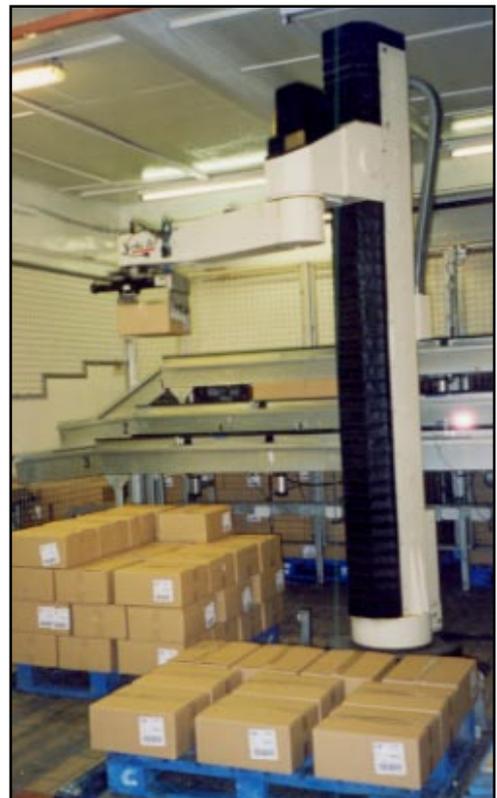
The company installed a 'pick-and-place' robot which lifts the boxes off the conveyor and palletises them to the correct height, pattern and variety.

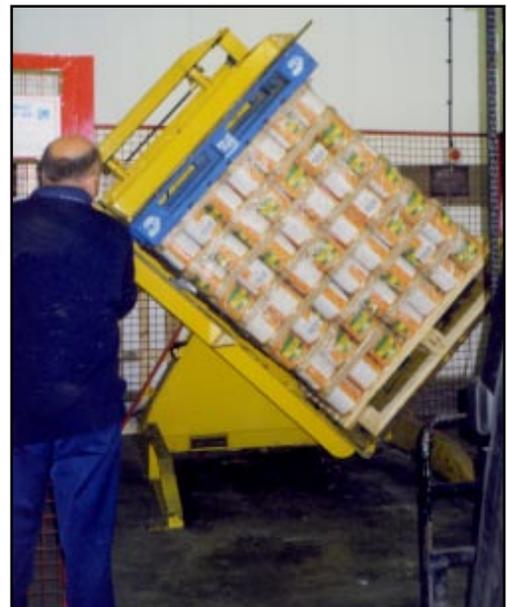
A pallet converter was purchased. The correct type of pallet was placed upside down on top of the customer's order on the incorrect pallet. A fork-lift truck was used to lift this structure ('pallet sandwich') into the pallet converter. The converter had four metal parts, consisting of an upper and lower panel, a back panel and a right panel. Once the structure was in place, the operator pressed a button on the control box to lower the upper panel of the converter onto the structure. This panel was equipped with a pressure sensor to ensure it was lowered to a height that held the structure in place, without damaging its contents. When the four sides of the converter retained the structure, the operator activated the machine. The converter slowly rotated 180° in a clockwise direction and its contents were turned upside down, such that the original bottom pallet was at the top. The upper panel of the converter was then raised and the structure removed from the converter using a fork-lift truck. The upper pallet was then removed manually.

The cost of the pallet converter was approximately £8000.

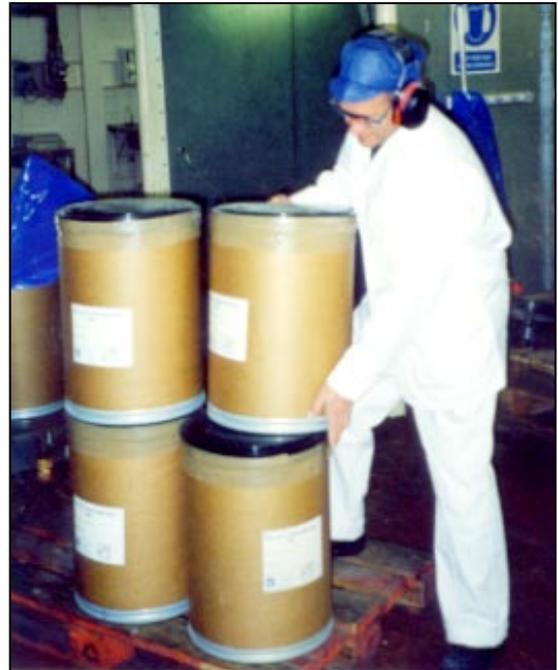
- The kegs were difficult to grasp and carry.
- Operators were forced to hold the load away from the trunk, to stoop, twist and to reach upwards.
- Complaints had been received from the workforce regarding the weight of the kegs and the carrying distances.

The company carried out a risk assessment and held discussions with the workforce. It was decided that alternative packaging should be sourced to bring the task in line with the Manual Handling Operations Regulations 1992. The company encouraged its customers to receive product in 10 kg cardboard boxes (37.5 cm square) instead of the 25 kg kegs.

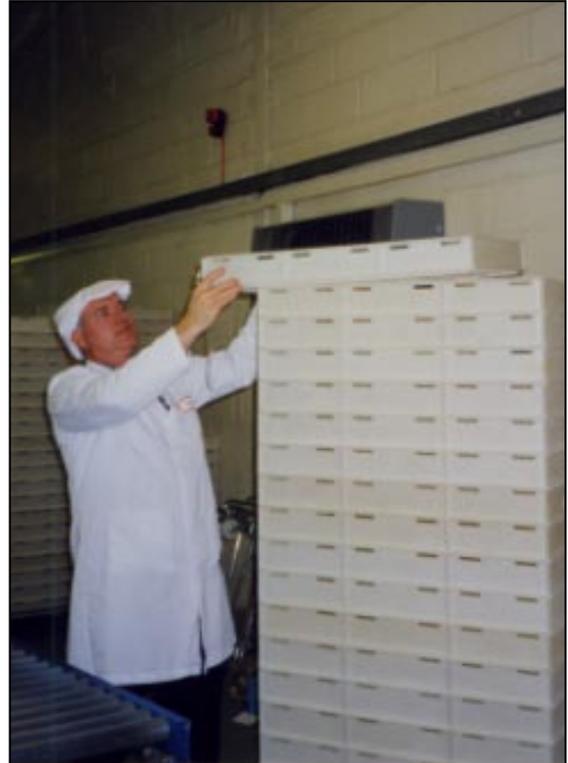
The company operated a 'batch' manufacturing process for producing medicinal sweets, such as throat pastilles. As the product is medicinal, they needed to carry out tests on the levels of active ingredients in each batch of product. The product was held in plastic trays for up to three weeks, awaiting testing. As each tray of product came off the line, the trays were stacked on trolleys, up to 20 trays high. An extra, empty tray was placed on top of the stack to act as a lid. They were then pushed to the air-conditioned and dehumidified holding area. When the product had passed the quality control tests, the stack was wheeled to the packing area. Staff would pick each tray off the stack, and tip them into the hoppers of the packing machine.

The weight of each tray was between 5 and 10 kg, and the dimensions of each tray were 75 x 40 x 10 cm. The total weight of a stack of trays could be as much as 200 kg. Trays were often overloaded, and/or asymmetrically loaded so they were heavier at one end than the other. There were no (designed) handholds on the trays, although the sides were relatively easy to grip. The total height of a stack of 20 trays and a trolley was 215 cm.

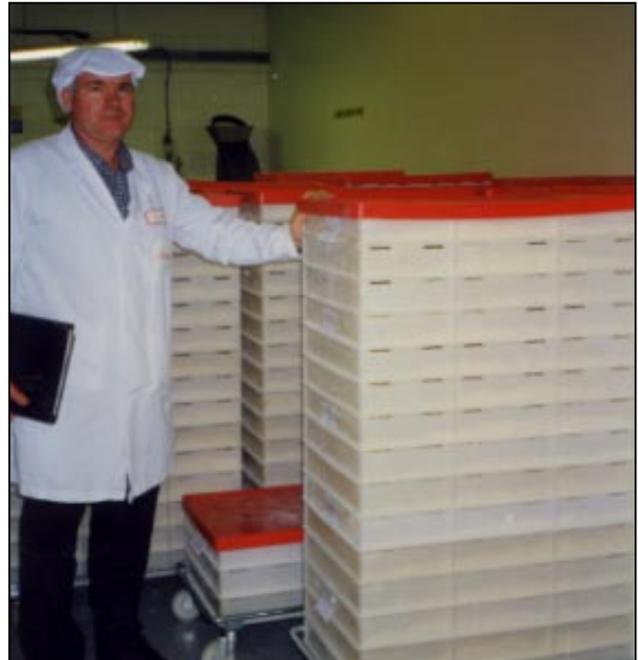
The company purchased 86 new trolleys, and put in a procedure to limit the height of the stack to 15 trays. The new trolleys had larger diameter wheels (10 cm) which were easier to pull and push. They also purchased special 'lids' to put on the top of the stack. The height of the stack was thus limited to 1.6 m. The cost of the extra trolleys and lids was £5000.

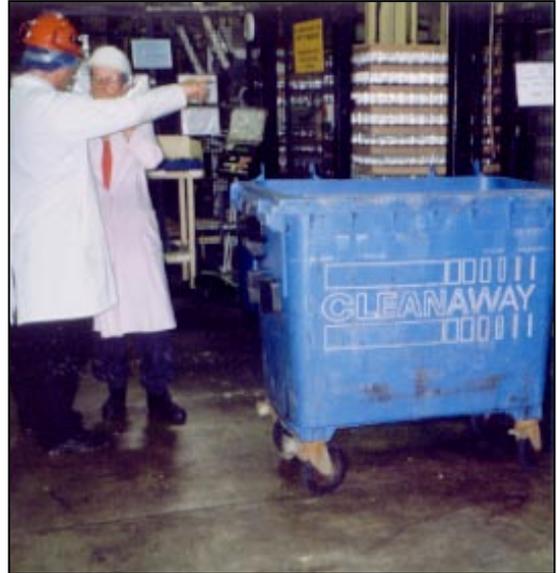
The company bought six mini-skips to replace the wheelie bins were placed at various points on the line, at an approximate cost of £650 each. When the mini-skips are full they are lifted by a fork-lift truck and transported to an outside waste dock, where they are emptied.

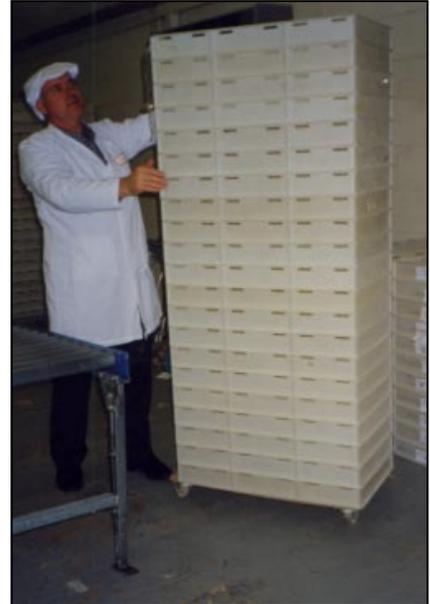
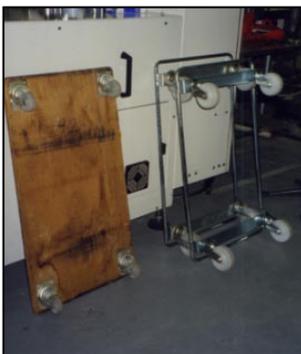
The company manufactured medicinal sweets, such as throat pastilles. As each tray of product came off the line, the trays were stacked up to 20 high on a wooden trolley, with an empty tray on top acting as a lid. They were then pushed to the air-conditioned and dehumidified holding area. When the product had passed quality control tests, the stack was pushed or pulled to the packing area.

The company identified four manufacturers of trolleys. They tried out each manufacturer's trolley in their own factory environment. One was too heavy; one had sharp edges; one was expensive (£65). The fourth was lighter, had no sharp edges, was easy to use for this company's product, and cost £32. It also had a metal ring which helped prevent the stacks from sliding off the trolley if it hit an obstruction on the floor. The company purchased 320 of these trolleys, to replace the wooden ones. The total cost was approximately £10 000.

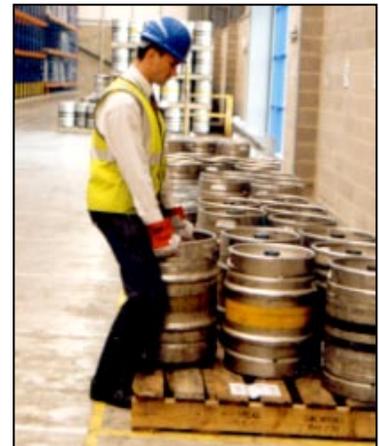
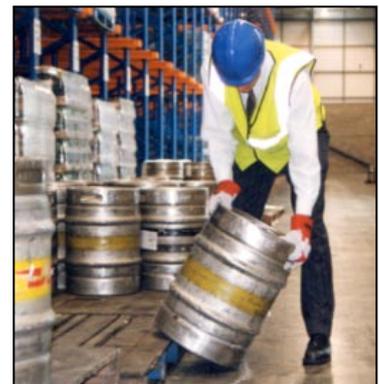
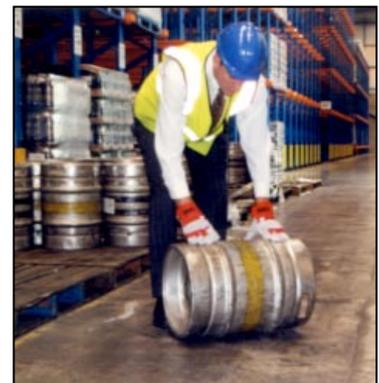
The operator holds the keg by its handles and slowly tips it on its side. The keg is rolled, at a pace at which it can be stopped quickly, to the new area. Once at its resting place, the keg is stood upright by its handle.

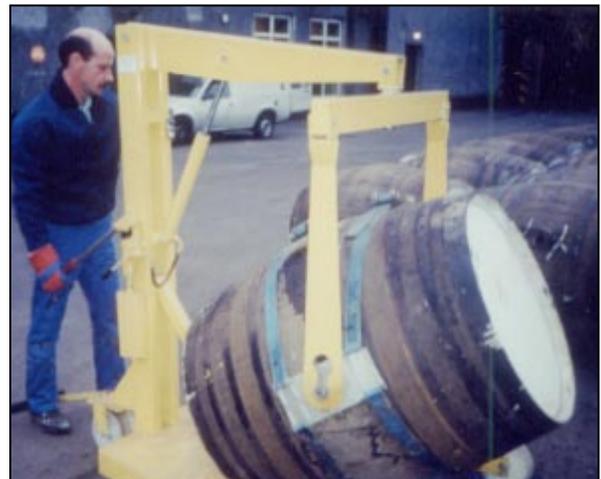
A portable cask-upender has been developed which allows a single person to upend the cask with mechanical assistance. The operator attaches straps to the centre of the cask, positions the device, and connects the upender's couplings to a hinge on the straps. He then pumps a lever to raise the arm, orientates the cask to the upright position, and lowers the arm. Using the device reduces the operator's effort to the relatively light pumping action required to raise the arm, greatly reducing the musculoskeletal stress and risk of injury. Furthermore, it entirely removes the risk of the cask slipping while being upended and falling towards the operators. The device cost £3000 to develop.

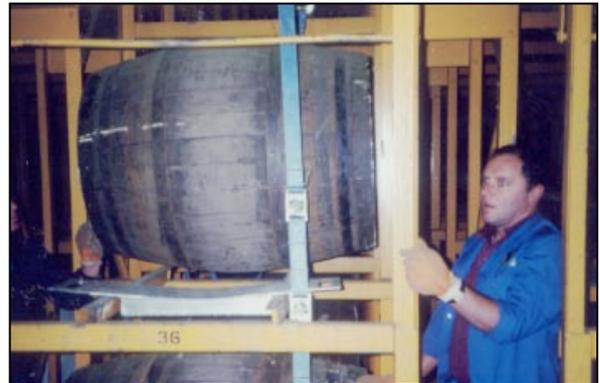
A common problem in the storage of casks of whisky is moving the casks on the two rails on which they are stored to age. The casks are normally stored lying sideways across the rails with the bung (cork) located at the top portion (between 10 and 2 o'clock) of the barrel. If the bung was not in the correct position, two warehouse staff turned the 500 kg cask by standing at either side of the cask and pushing it forwards and backwards to progressively turn the cask to the right position. This task was performed two or three times per day on average. A similar but even more demanding task was repositioning a cask which had turned 90° so that it was lying between and parallel to the rails. In this case the operators had to pull and lever the cask into the correct position across the rails, and also ensure that the bung was located at the top of the cask.

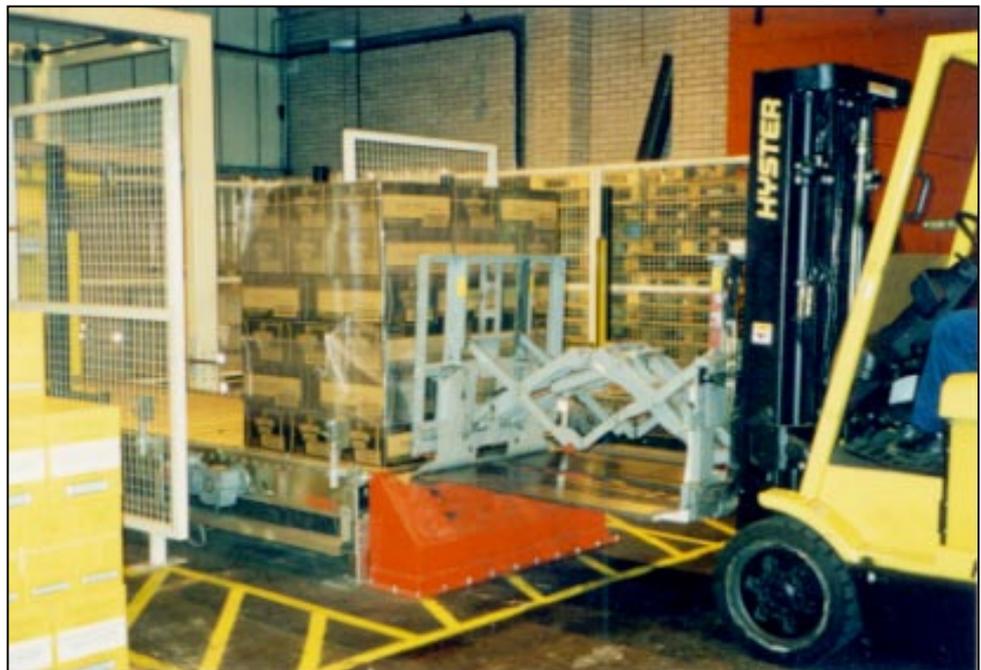
The company identified a modification to fork-lift vehicles that would enable them to use 'slip mats'. These are thin pieces of cardboard, of the same dimensions as a pallet, onto which the boxes can be stacked automatically to the correct height for the container vehicle, then fork-lifted straight into the vehicle. The slip mats waste very little space, are infrequently damaged, and cost only 80 pence each.

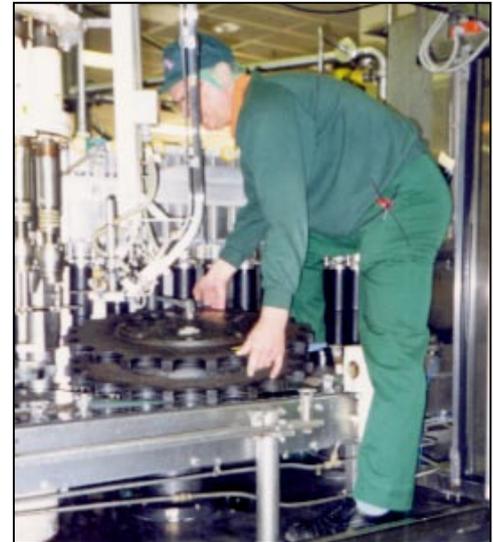
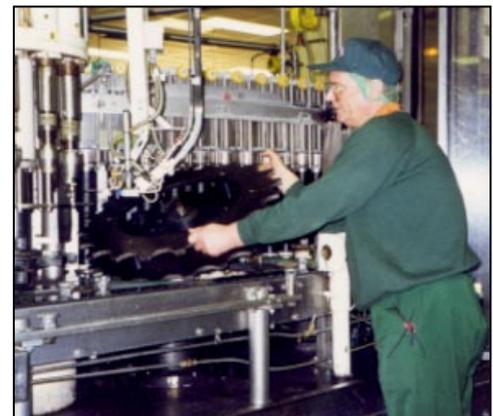
As soft drinks bottles were transferred from a filler to an outfeed conveyor for labelling, they were fed gently around a curve by a 'star wheel'. When production changed to a different shape and size of bottle a different size star wheel was required. The star wheels, which weighed 20 kg and measured approximately 60 cm in diameter, had to be changed manually by an operator. This task was carried out once or twice a day depending on production requirements.

The company replaced the existing star wheels with lightweight versions. The new star wheels have all unnecessary material taken out of them (eg the centre of each wheel is now cut out). They contain only half the material, weighing only 10 kg, but retain rigidity. Replacing the star wheels cost approximately £4000.

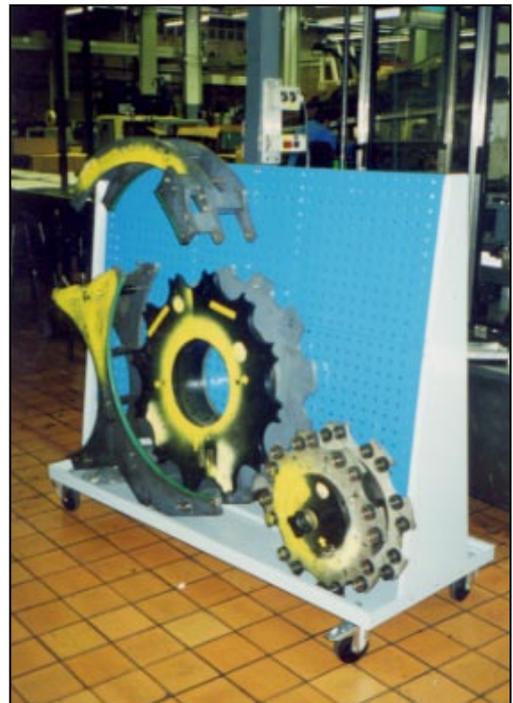
While the originals were built in-house, parts trolley are now available on the market at a cost of approximately £400. The photograph shows a trolley that is available commercially as a flat-pack which can be assembled easily on-site.

Although the machine-changing occurs relatively infrequently, it was recognised as containing manual handling risks associated with heavy lifting and carrying. The company designed and built a parts trolley in-house that could be wheeled from the machinery store to the appropriate line. The heaviest parts were stored at the most comfortable heights for handling and, for the heaviest lifts, two people work as a team to fit the machinery onto the line. The cost of the trolleys was less than £200.

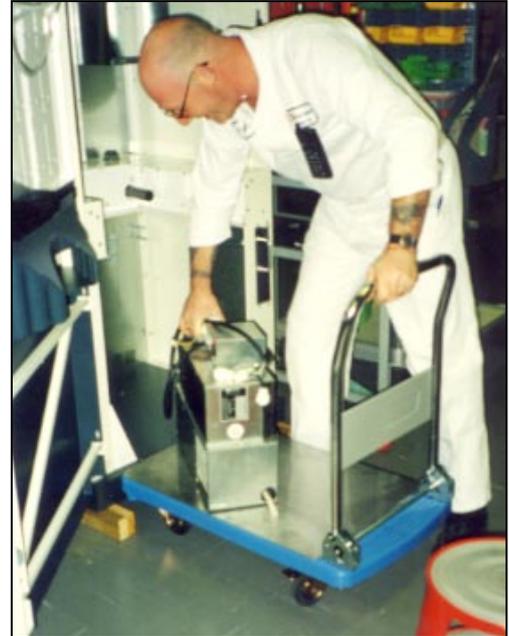
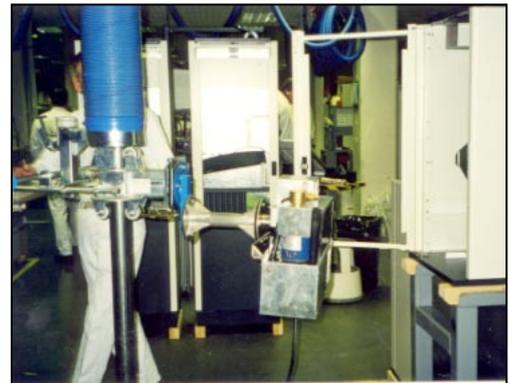
The company bought a lifting machine to lift the chillers off the delivery trolleys and place them directly into the vending machines. However, the lifting machine was slow and cumbersome to use, and not particularly user-friendly. Visibility within the vending machine was another problem. For these reasons, staff reverted to lifting the chillers manually.

The engineering team went back to the drawing board and brainstormed the problem with an ergonomist and two members of the factory staff. They determined that one of the most risky parts of the task (lifting the chiller into the machine) could be reduced to a sliding task rather than a lifting task. To achieve this, they purchased trolleys which could be set at the same height as the delivery pallets and the vending machine floor, and fitted a special stainless-steel, friction-free surface onto them. They also fitted small feet onto the undersurface of the chiller units so that they would slide easily over the stainless- steel surface of the trolley and the vending machine floor. The cost of making the changes was very low - about £300 in total. The lifting machine is now used to unload chillers onto the trolleys only.

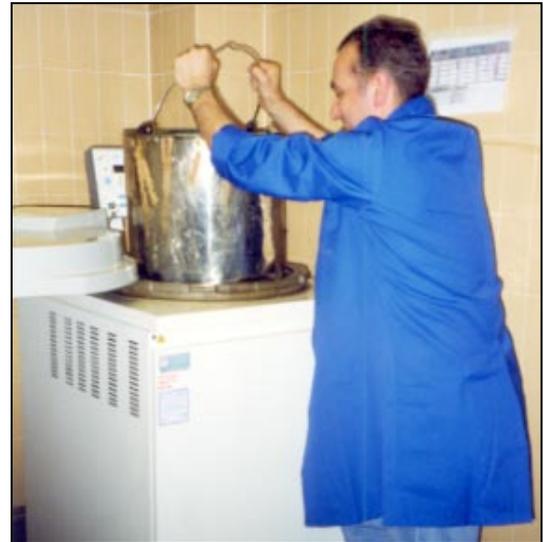
In the laboratories of a brewery, apparatus was sterilised in three top-loading autoclaves. The apparatus was loaded into a large metal basket (0.5 m diameter), weighing 20 kg or more, lifted by a thin wire handle to above chest height, and into the autoclave. When the apparatus was sterilised, the basket was lifted out of the autoclave by an operator wearing gloves. This task was carried out approximately five times a day.

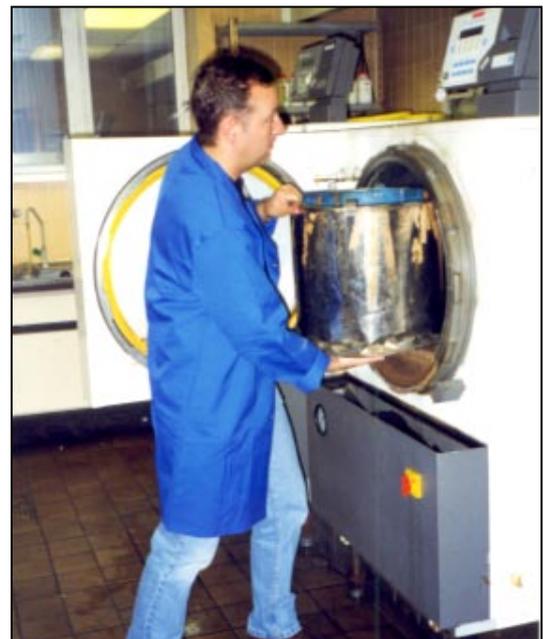
The company replaced two top-loading autoclaves with front-loading autoclaves at a cost of approximately £20 000.

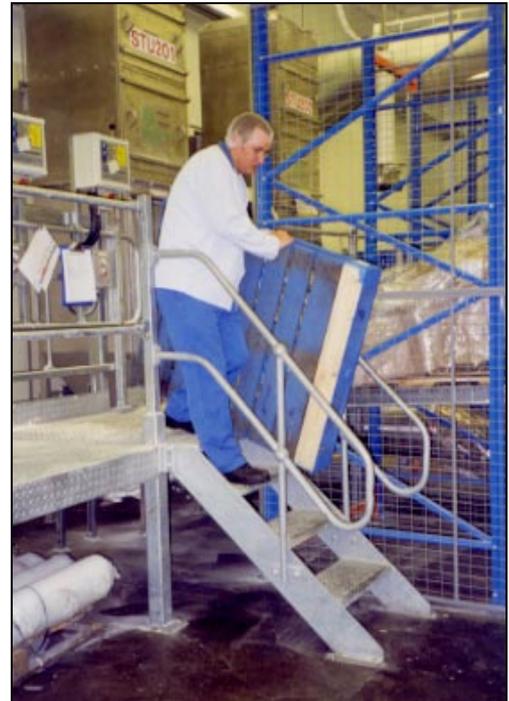
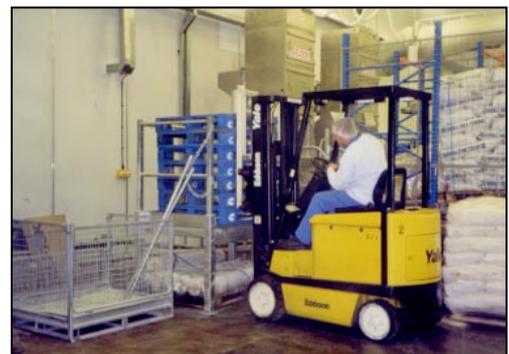
The company built a platform on which the empty pallets could be stacked until they were removed with a fork-lift truck. The platform cost approximately £1000.

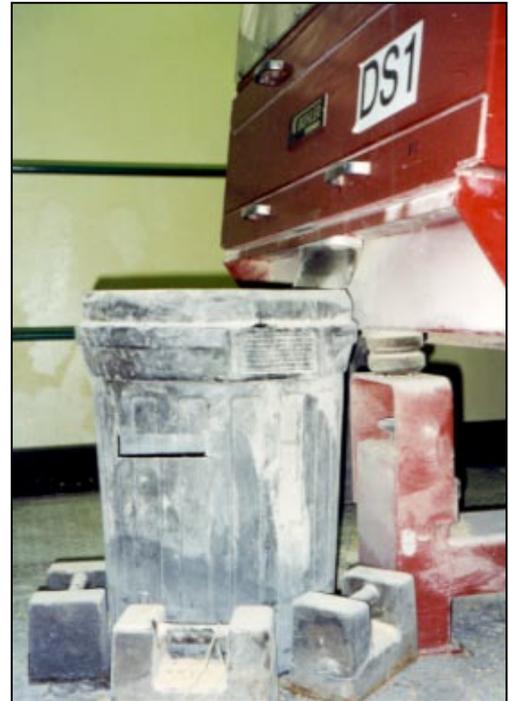
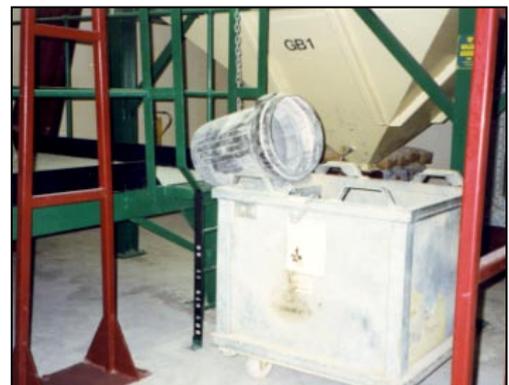
Following a risk assessment, the company cut slots into the sides of the plastic bins to prevent them from being overfilled. They also purchased a 1000 kg wheeled mini-skip at a cost of approximately £500, which was placed next to the platform. When the bins needed emptying, they were tipped from the platform into the mini-skip. When the mini-skip was full, it was pushed to the lift, taken to ground level and lifted by fork-lift truck to empty it into a larger skip.

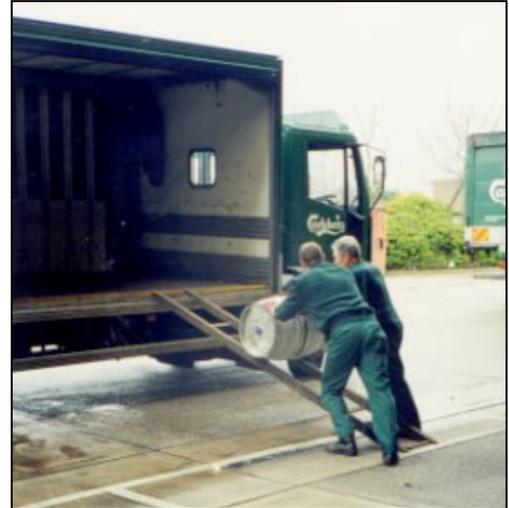
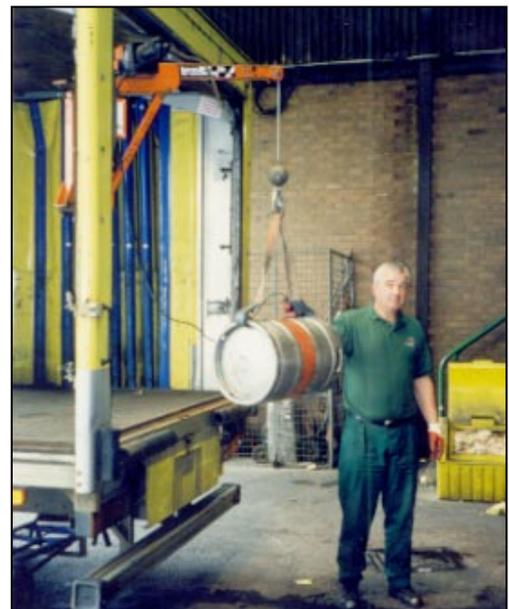
One arm of the brewing and distribution industry worked in conjunction with a major engineering firm to help develop a swing-lift hoist that can be fitted to the rear post of any vehicle that is equipped with a power source and a fitment bracket. The hoists allow the kegs to be lifted direct from the floor onto the vehicle by means of attached straps and hooks. The company has purchased several hoists, each costing approximately £1500 and the plan is already under way to equip vehicles at each distribution depot.

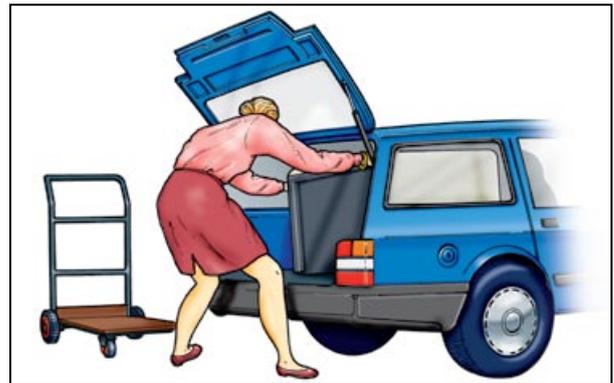
A sales force (50-100 people) carried out demonstrations of 'table top' vending machines at potential customer premises. They drove to the customer premises with the vending machine in the back of an estate car. On arrival at the customer site, the sales consultant had to get the vending machine out of the back of the car onto a trolley, wheel it to the demonstration room, lift it into place and set it up, demonstrate it, then do the process in reverse. Often they had to pull it over long distances, if there was no parking nearby, and manoeuvre it in and out of lifts and along narrow corridors. The sales consultants would carry out two or three of these demonstrations per month.

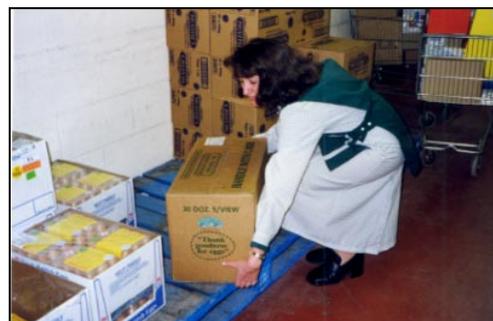
Eggs were delivered to a supermarket in palletised boxes. Each box contained 30 dozen eggs and weighed approximately 25 kg per box. Supermarket staff were transporting boxes to the shop floor display fixtures by means of a trolley and removing the eggs from the boxes onto the display.

Staff were experiencing back problems from lifting the boxes onto the trolley.

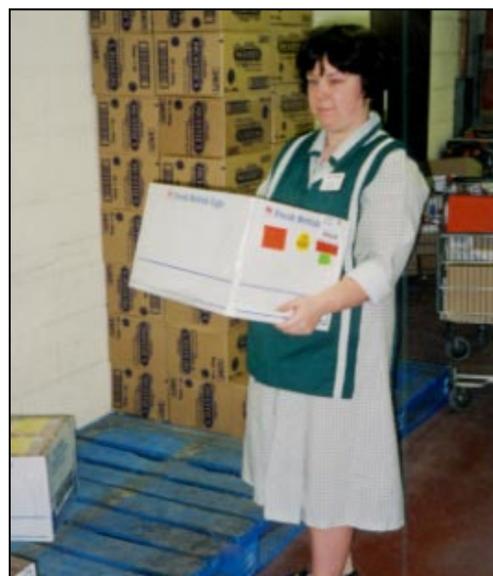
Following complaints from staff with regard to the weight of the boxes, a risk assessment was carried out. The company then put pressure on their egg supplier to deliver the eggs in smaller boxes. These smaller boxes contained 15 dozen eggs and weighed approximately 13 kg.

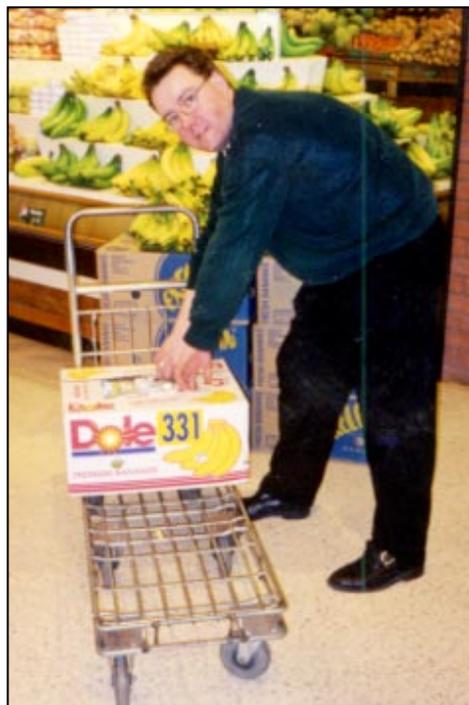
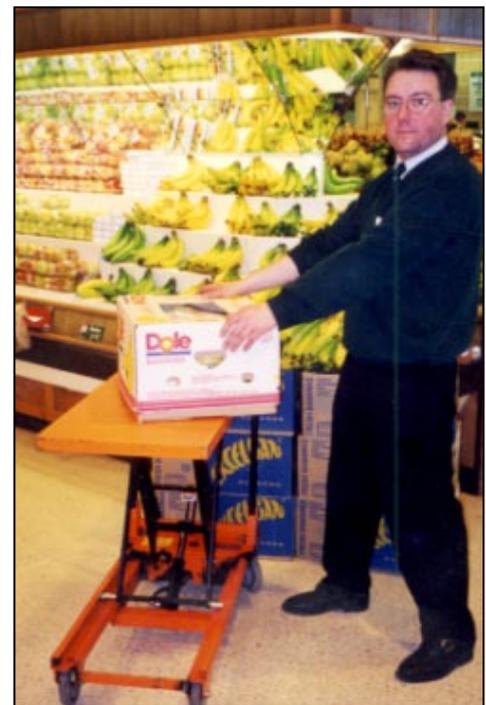
Staff were experiencing back problems from stooping to empty the boxes from the flat-bed trolleys.

Following complaints from staff, a risk assessment was carried out on the lifting element of this task. The company identified and sourced a hydraulic lifting truck which could be pumped up (by foot) to bring the boxes in line with the display fixtures. A truck was purchased for each of the 14 stores in which they could be manoeuvred, at a cost of approximately £410 each.
